Leaking of Liquid Manure Storages - Literature Review

Ron Fleming, Jennica Johnston, Heather Fraser

Ontario Pork

July, 1999

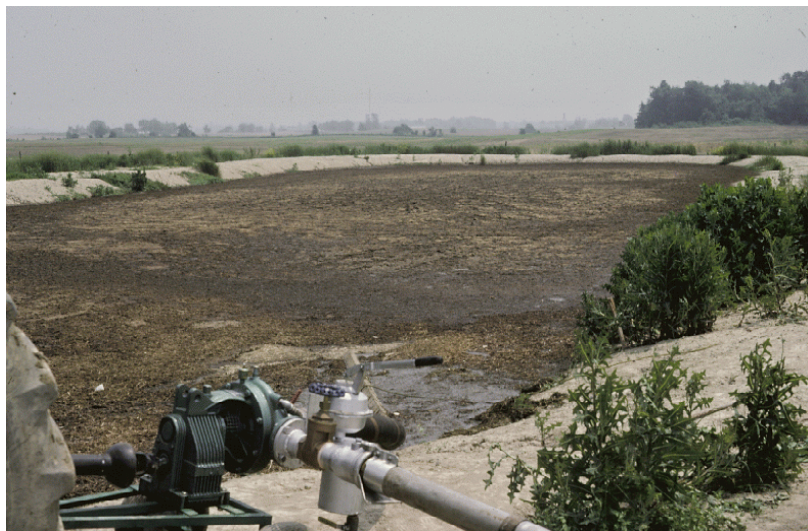
Figure 1 Earthen manure storage during pump-out

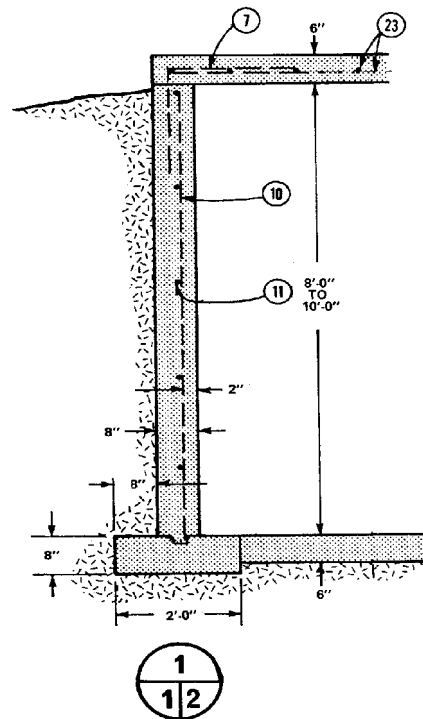
Figure 2 Detail from Canada Plan Service Plan 8712 showing cross-section of in-ground concrete tank with typical wall, footing, floor, and roof details

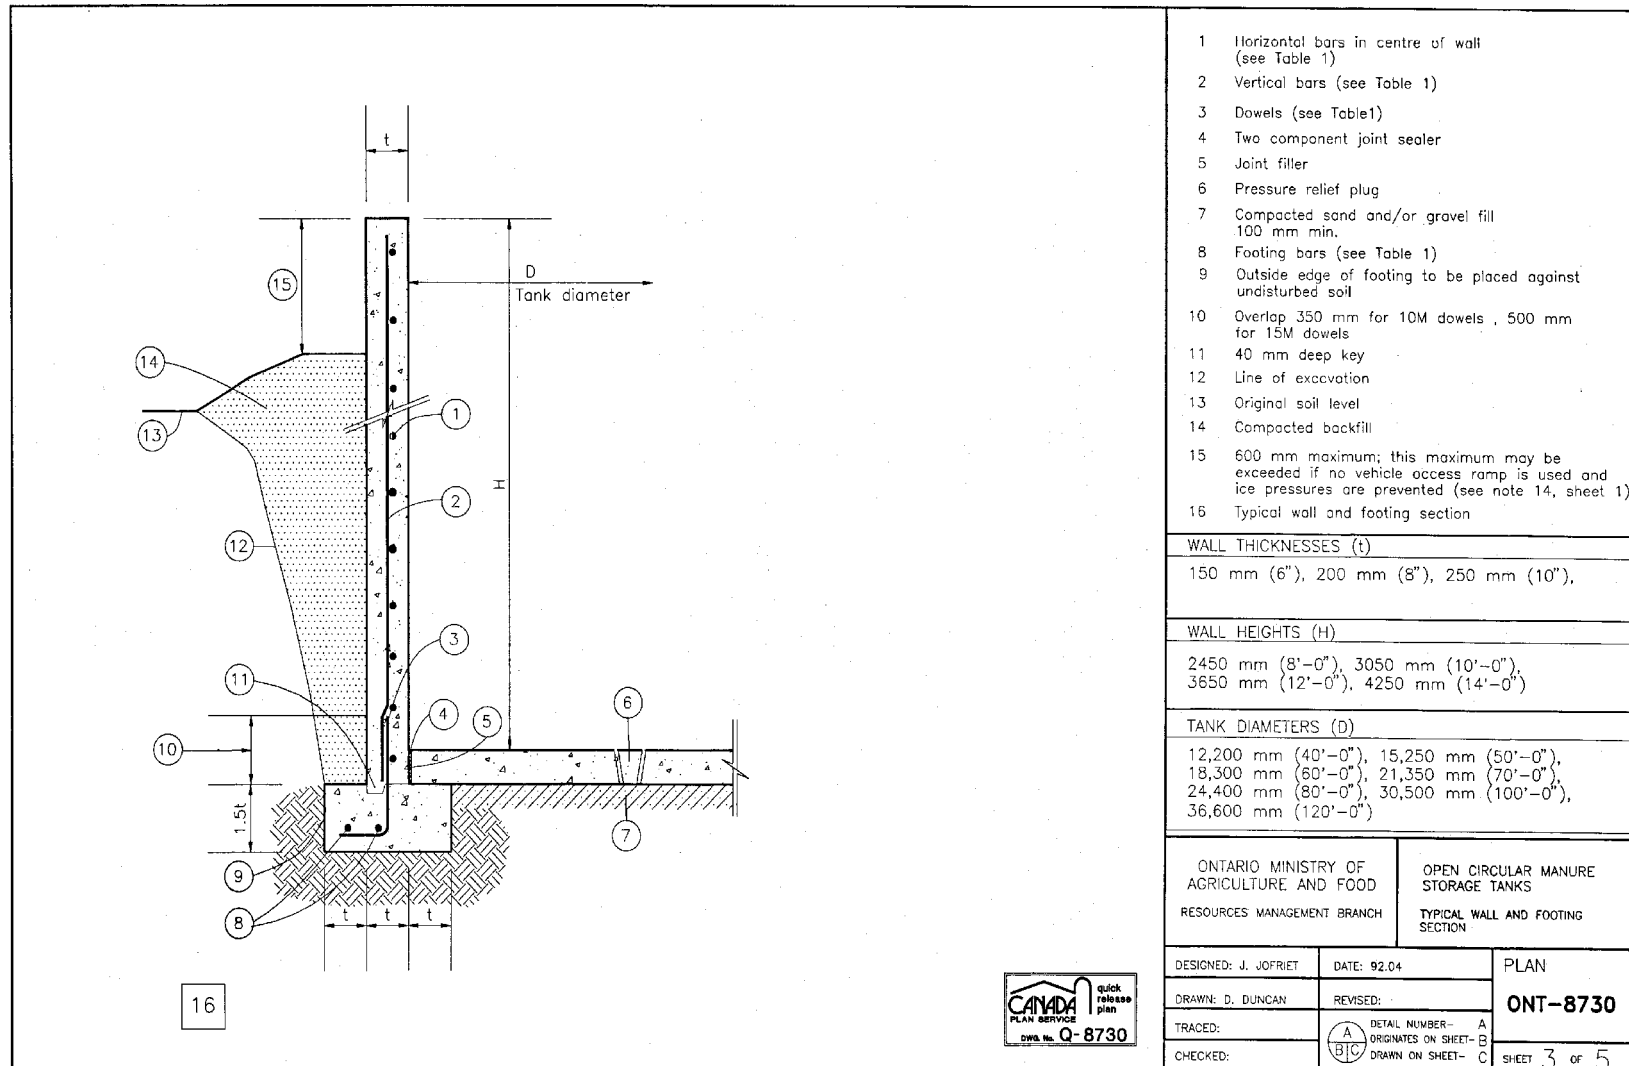
- 1 Horizontal bars in centre of wall (see Table 1)
- 2 Vertical bars (see Table 1)
- 3 Dowels (see Table 1)
- 4 Two component joint sealer
- 5 Joint filler
- 6 Pressure relief plug
- 7 Compacted sand and/or gravel fill 100 mm min.
- 8 Footing bars (see Table 1)
- 9 Outside edge of footing to be placed against undisturbed soil
- 10 Overlap 350 mm for 10M dowels, 500 mm for 15M dowels
- 11 40 mm deep key
- 12 Line of excavation
- 13 Original soil level
- 14 Compacted backfill
- 15 600 mm maximum; this maximum may be exceeded if no vehicle access ramp is used and ice pressures are prevented (see note 14, sheet 1)
- 16 Typical wall and footing section

WALL THICKNESSES (t)
150 mm (6"), 200 mm (8"), 250 mm (10"),
WALL HEIGHTS (H)
2450 mm (8'-0"), 3050 mm (10'-0"), 3650 mm (12'-0"), 4250 mm (14'-0")
TANK DIAMETERS (D)
12,200 mm (40'-0"), 15,250 mm (50'-0"), 18,300 mm (60'-0"), 21,350 mm (70'-0"), 24,400 mm (80'-0"), 30,500 mm (100'-0"), 36,600 mm (120'-0")

ONTARIO MINISTRY OF AGRICULTURE AND FOOD RESOURCES MANAGEMENT BRANCH	OPEN CIRCULAR MANURE STORAGE TANKS TYPICAL WALL AND FOOTING SECTION
---	--

Figure 3 Tank wall detail from Plan ONT-8730 showing wall, footing, floor (1992)

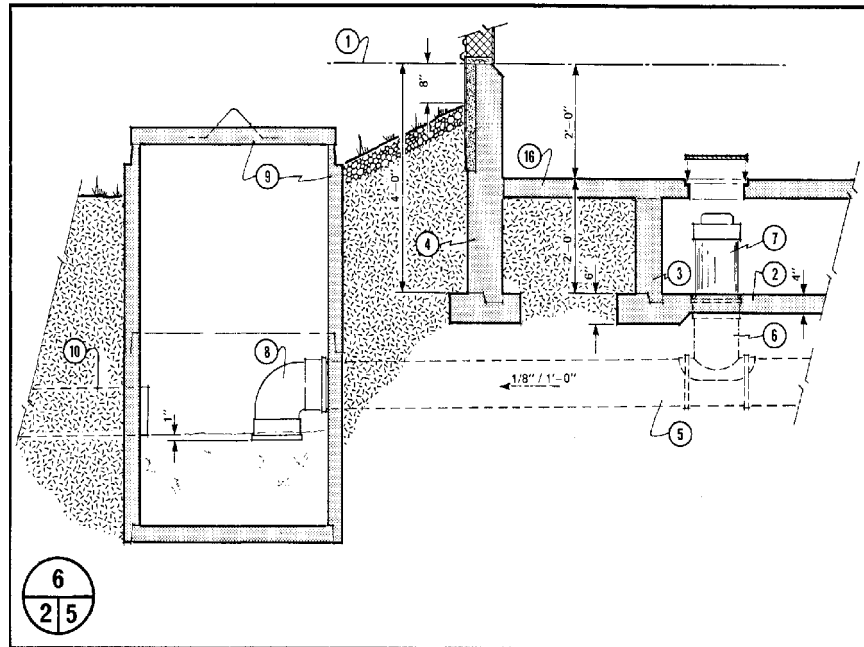
Figure 4 Detail from Canada Plan Service plan 3303 showing Saddle-T pipe connection (item 6) and horizontal drain pipe (item 5) in flush gutter system

2. A saddle-T connector. A hole is cut into the top of the horizontal pipe and the saddle-T sits over the hole. It is fastened into place with steel bands, and caulking should be applied to prevent leaks. Figure 4 shows an example of a flush gutter system found in a Canada Plan Service barn plan. The saddle-T connector, designated by item 6 on the drawing, is shown.
