**STREAM ASSESSMENT  
STECKLY DRAIN  
J. ROE FARM  
E. WILSON FARM  
R. WILSON FARM**

LOT 5-8, CONCESSION 5  
MORNINGTON TWP., PERTH CTY.  
UPPER NITH RIVER  
Grand River Conservation Authority

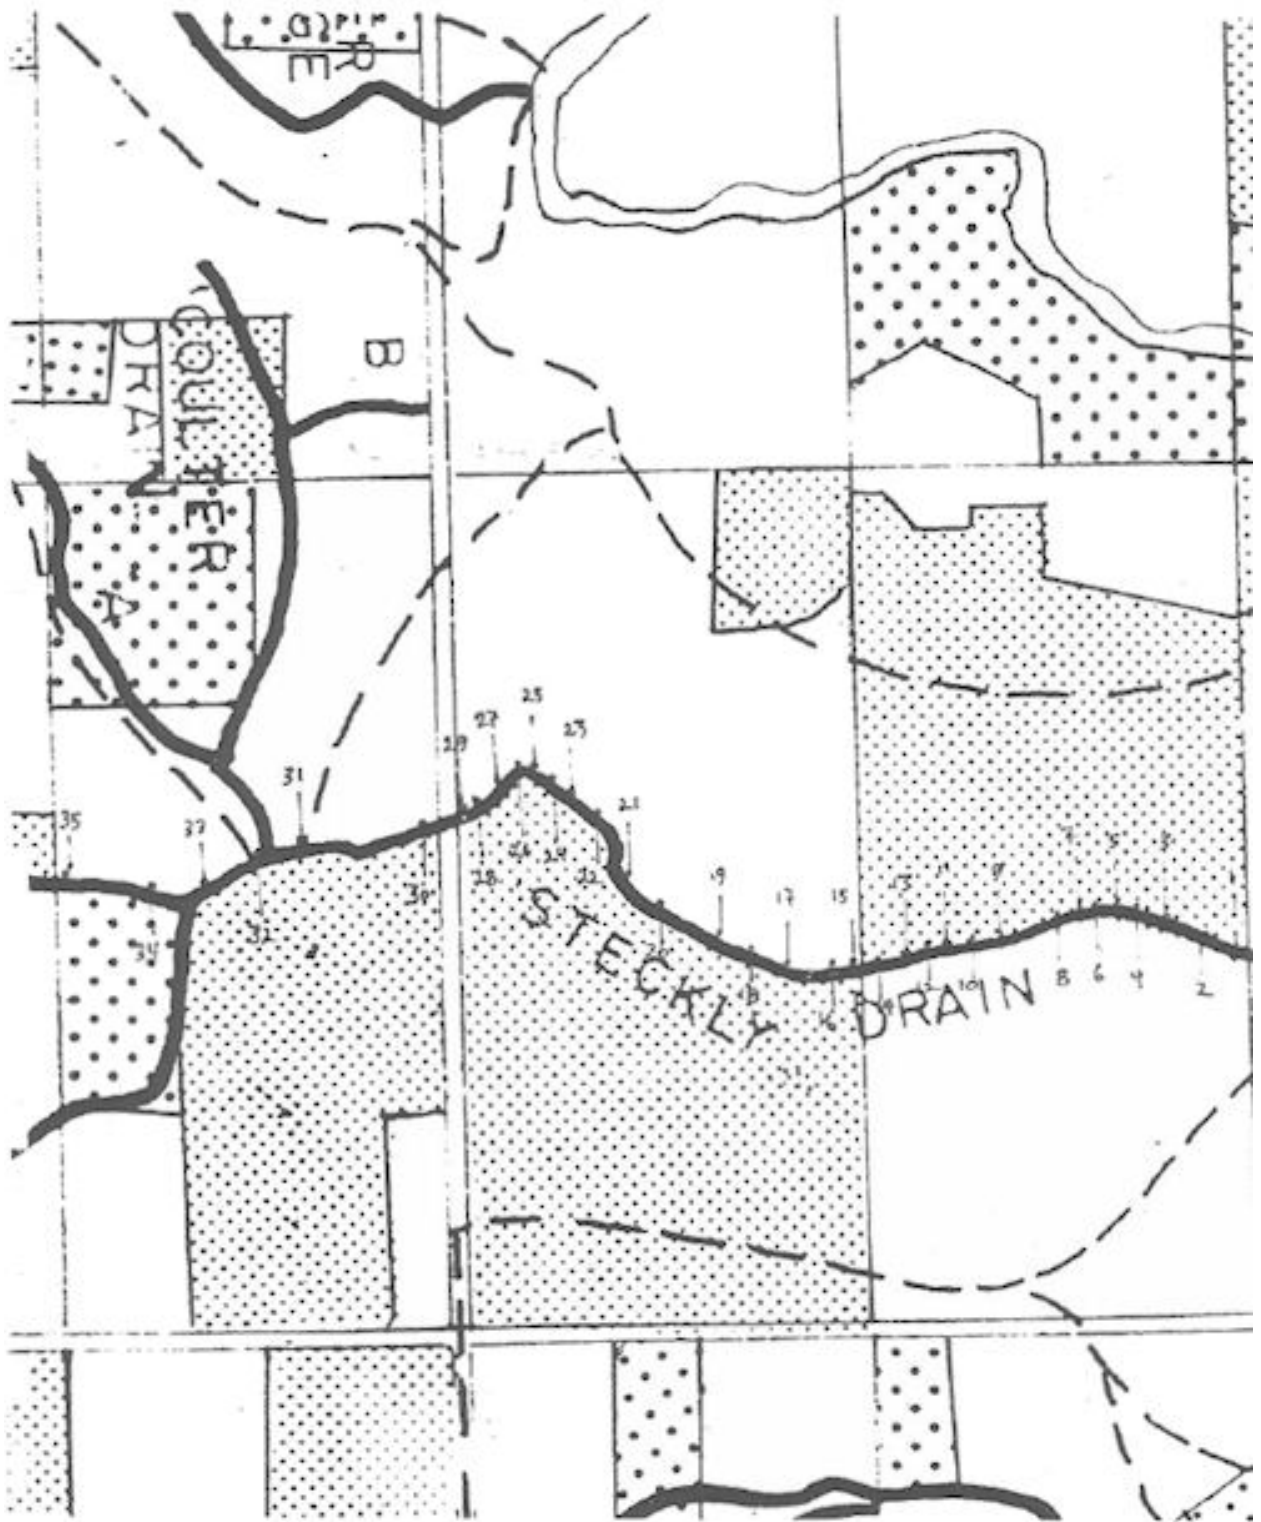
STECKLY DRAIN : SAMPLE SITES

Thirty-five stations were selected on the basis of total stream representation and potential impacts to stream health (e.g., tiles, erosion areas, wetlands, treed buffers). The thirty-five stations were visited from, June 9, 1994, to June 28, 1994. Weather varied from warm, to hot and sunny, to overcast. Sites selected are shown in Appendix 1.

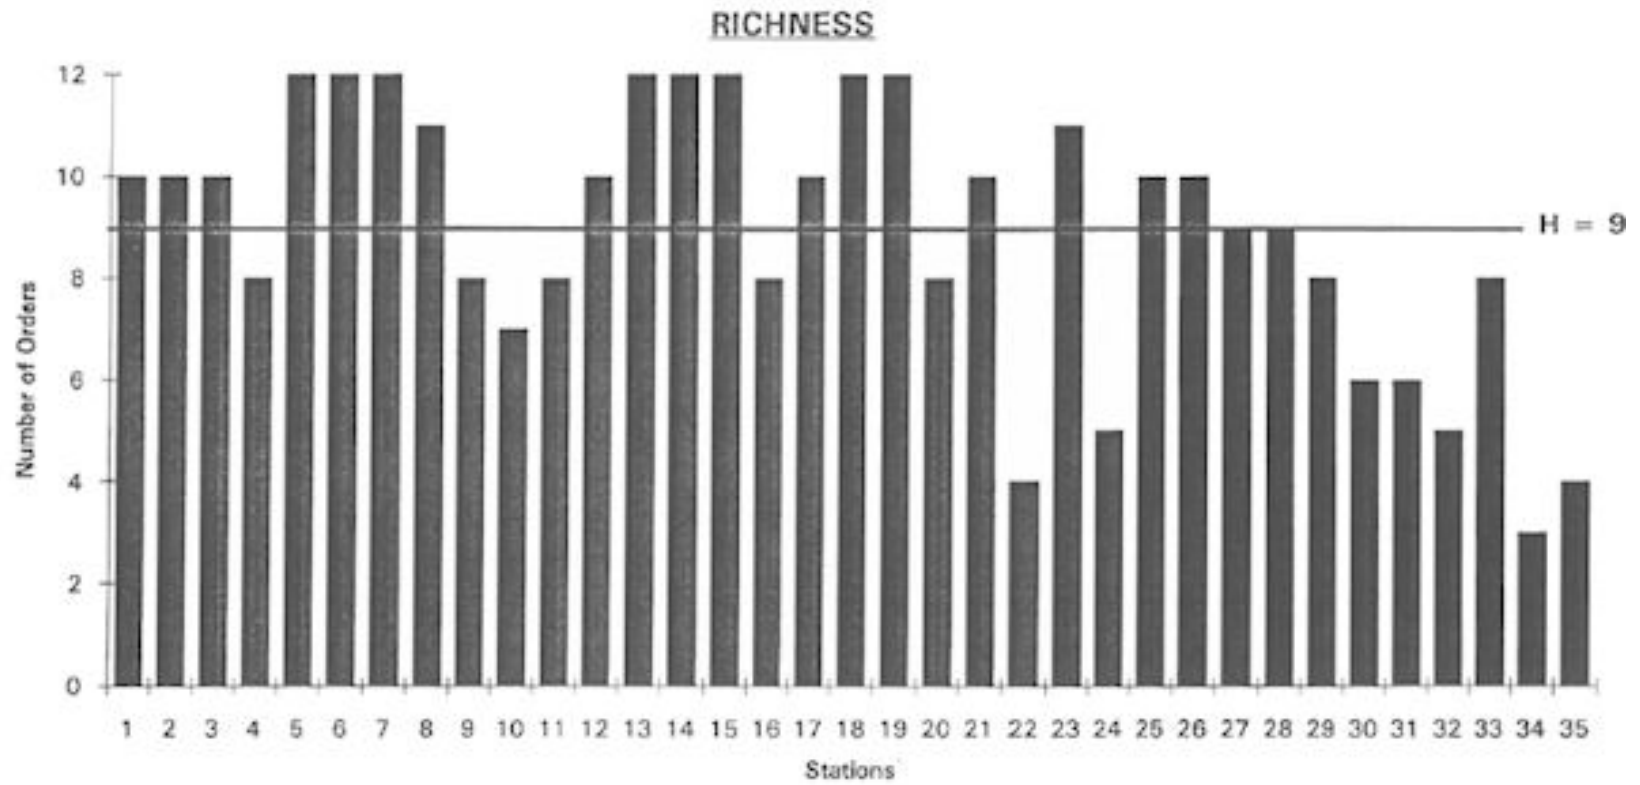
APPENDIX 2: Steckly Drain

In the Steckly Drain, sixteen taxa were identified. Most of the organisms identified were Haptotaxida (1321 individuals), Ephemeroptera (471 individuals), Coleoptera (325 individuals), Hemiptera (296 individuals), Amphipoda (216 individuals), *Chironomidae* (187 individuals), and Pharyngobdellida (166 individuals). All of the actual taxa found for each station or richness is located in Appendix 2.

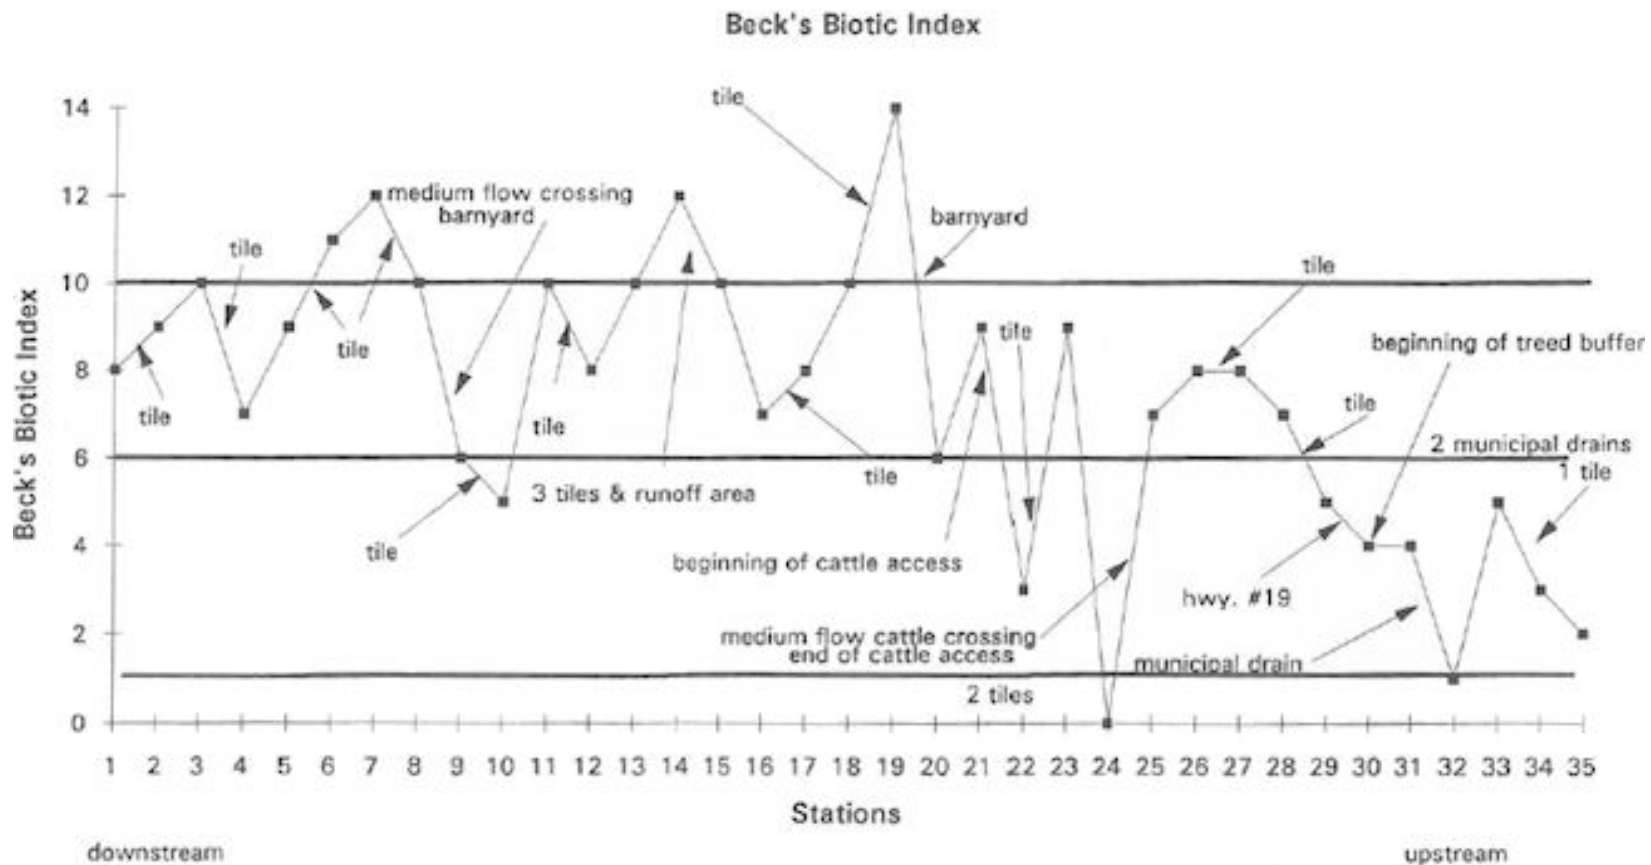
APPENDIX 3: Steckly Drain

The dominant Beck's Biotic Index class rating was Class 3 organisms, followed by Class 2 organisms. The highest Beck's Biotic Index value attained, was fourteen at station nineteen. Two stations were ranked grossly polluted. Ten stations were ranked moderately polluted. Nineteen stations were ranked clean but monotonous habitat and velocity. Four stations were considered to have clean water. The index demonstrated an upward trend from the upstream to downstream portion. Graphs demonstrating Beck's Biotic Index, for each station on the Steckly Drain, are found in Appendix 3.

B.I. = 0-1 grossly polluted; 1-6 moderately polluted; 6-10 stream clean but monotonous habitat and velocity; 10+ clean

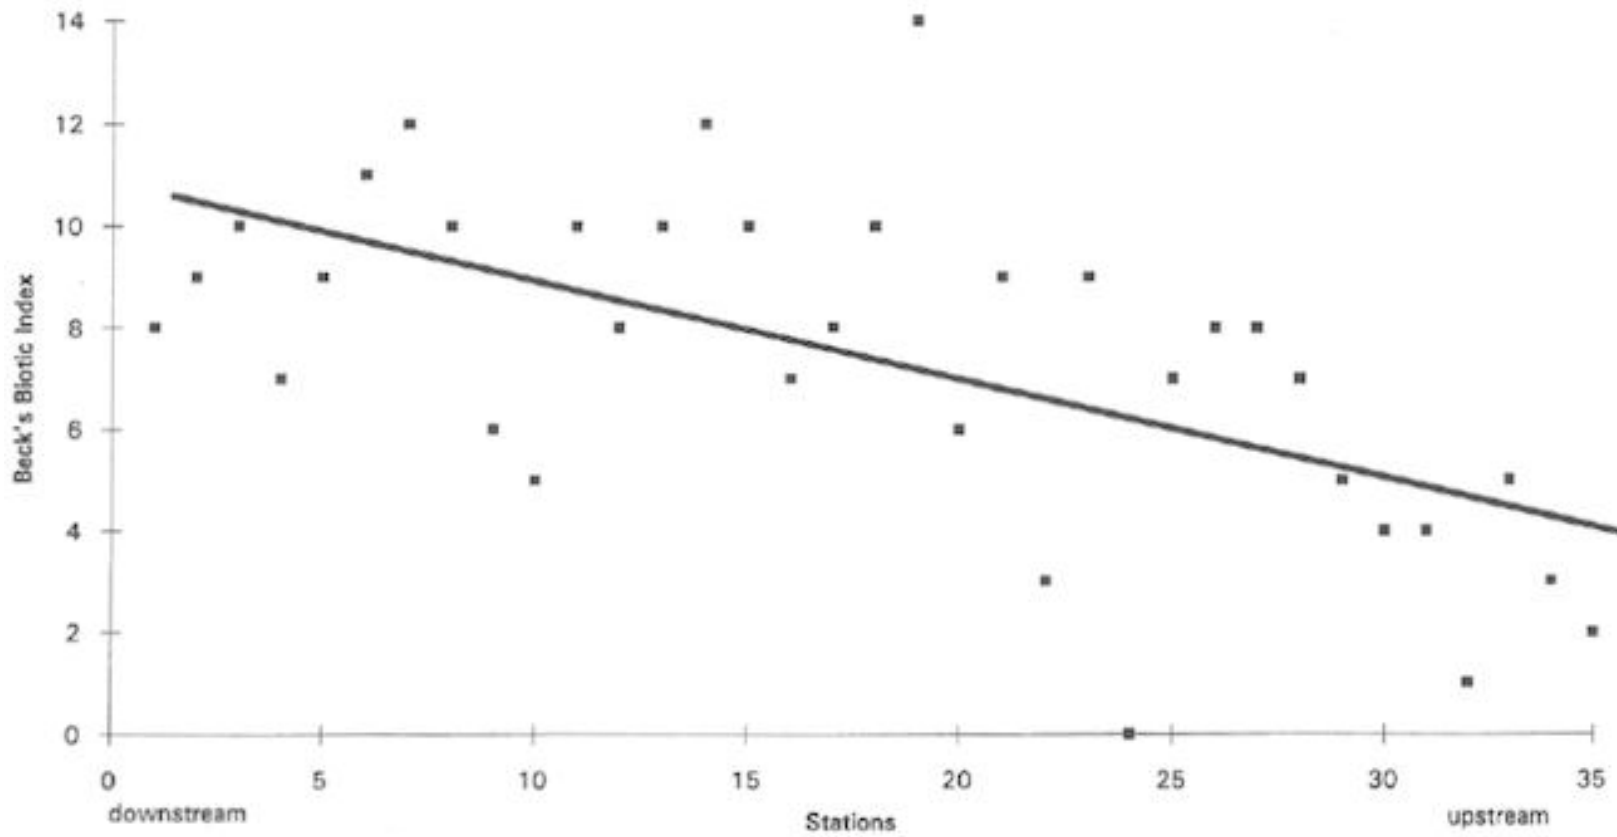
### APPENDIX 3 : Steckly Drain

B.I. = 0-1 grossly polluted; 1-6 moderately polluted; 6-10 stream clean but monotonous habitat and velocity; 10+ clean

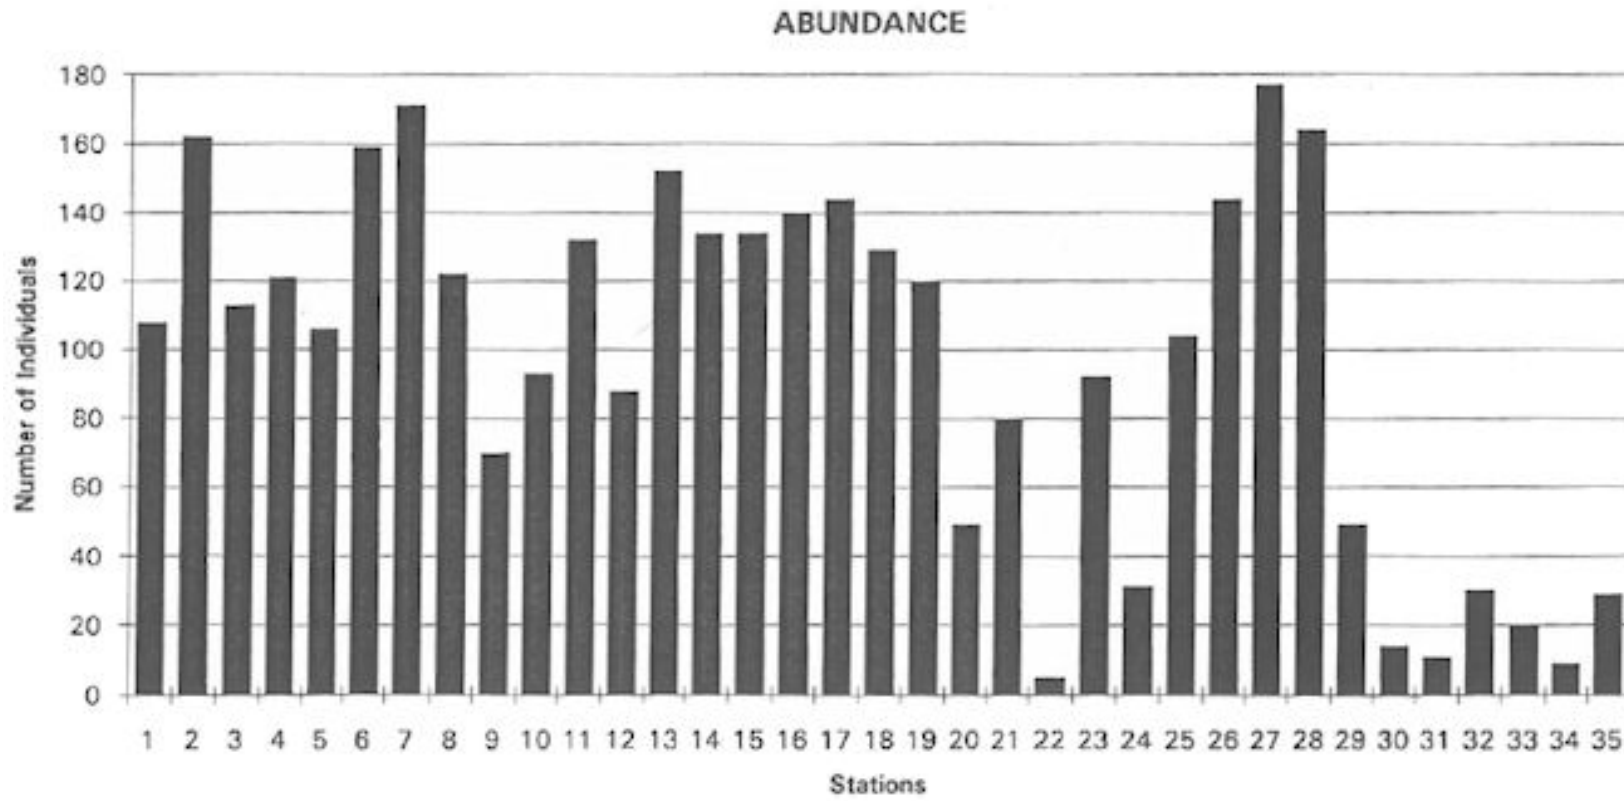
APPENDIX 5: Steckly Drain

The number of organisms sampled at each station varied from about 5 to 177. The largest numbers of organisms were identified in the mid-stream portion of the drain. The most abundant Class 1 and Class 2 organisms were found in the downstream portion of the drain. Data concerning abundance of organisms is located in Appendix 5.
