**UPPER THAMES RIVER LIVESTOCK  
MANURE AND WASTE MANAGEMENT PROGRAM**

Prepared by: Craig Merkley  
For: Ministry of Environment  
Southwestern Region

**KINTORE CREEK WATERSHED STUDY  
- 1987 PROGRESS REPORT -**

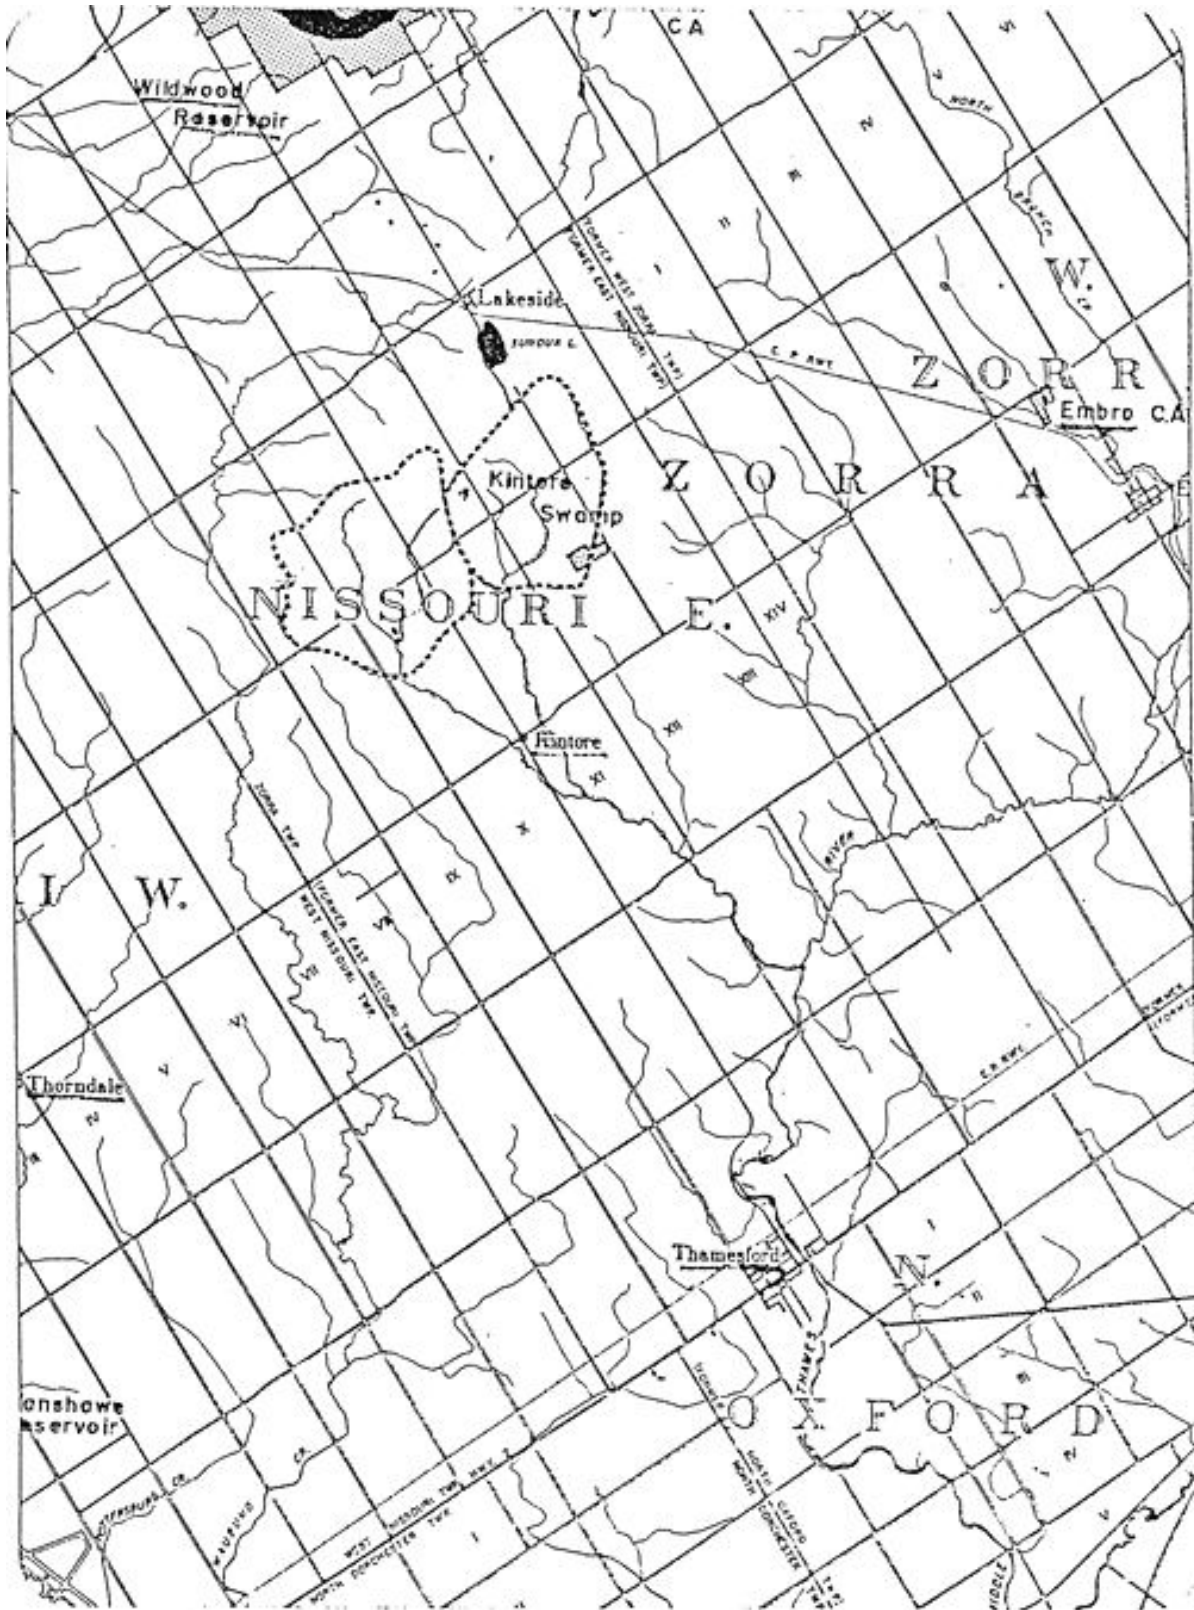
**Figure 1:** Location of Kintore Creek Paired Watersheds

Kintore Creek originates near the village of Kintore in Zorra Township, Oxford County. It flows in a southerly direction for approximately 10 miles before outletting into the middle branch of the Thames River near Thamesford (fig. 1).

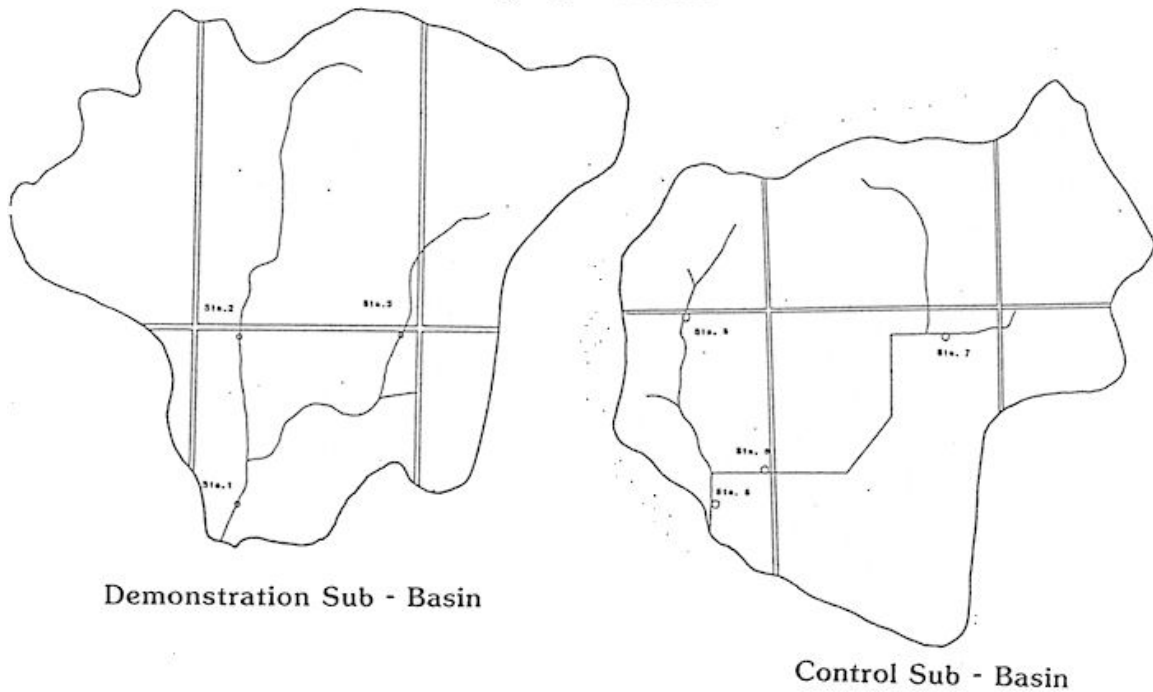
**Fig. 3:** Sampling Locations

To help determine the existing water quality condition in the two subbasins, a water monitoring program was established. Seven sampling stations were selected (fig. 3). Three are located in the western basin, -four are located in the eastern basin. To determine loadings, stage discharge curves were developed at each of these seven stations. Base level recorders were installed at the two outlets. To monitor storm events, ISCO automatic samples were also installed at the outlets. The water quality data has been tabulated and entered on computer for storage and future analysis.

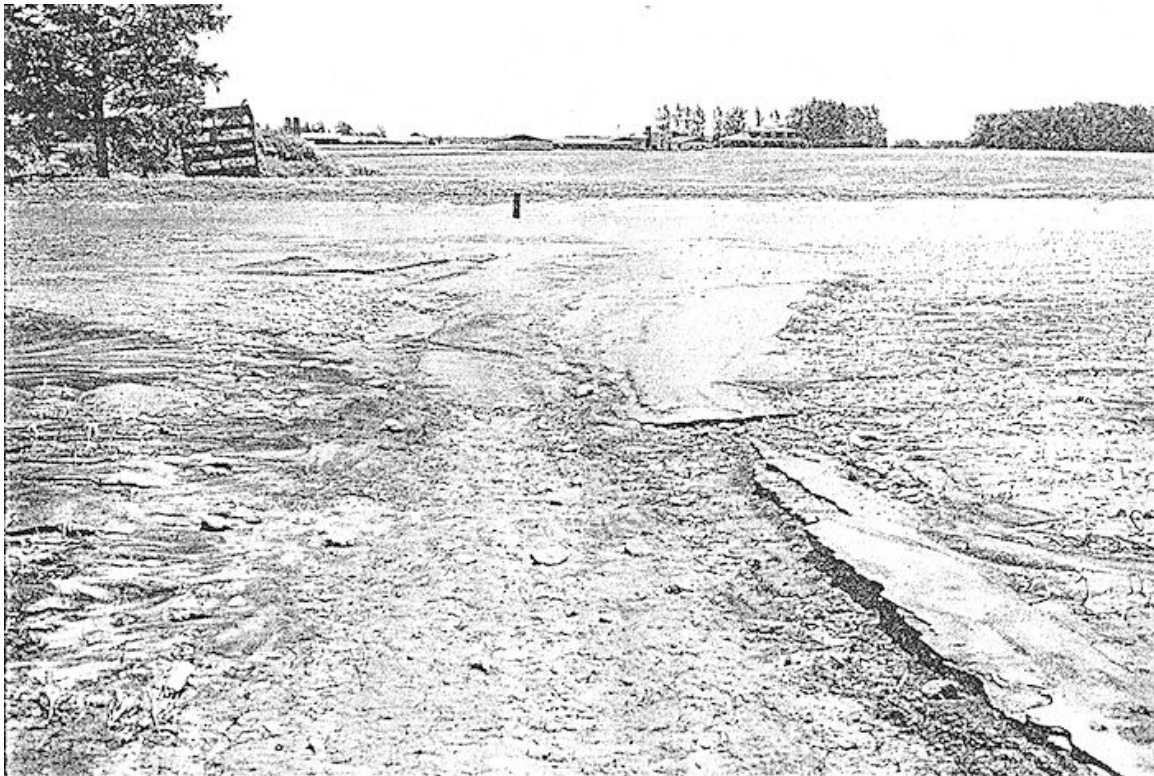
Although these structures do not reduce sheet erosion, they have helped farmers identify the sheet erosion problem. After severe storm events, deposition in the ponding areas can be quite noticeable (fig. 5). Farmers have seen this occurring and now recognize the additional sheet erosion problem. The structures have served as an educational tool, most farmers realize structures are only part of the solution to upland erosion.

**Fig. 5:** Structures help prevent gully erosion, but do not control upland sheet erosion.

To date, a total of 11 water and sediment control basins (WASCOBs) have been constructed in the demonstration basin. One waterway diversion has also been constructed. The WASCOBs are designed to control gully erosion. They pond runoff water during a storm event, then drain it slowly away to a safe outlet through an underground tile system.

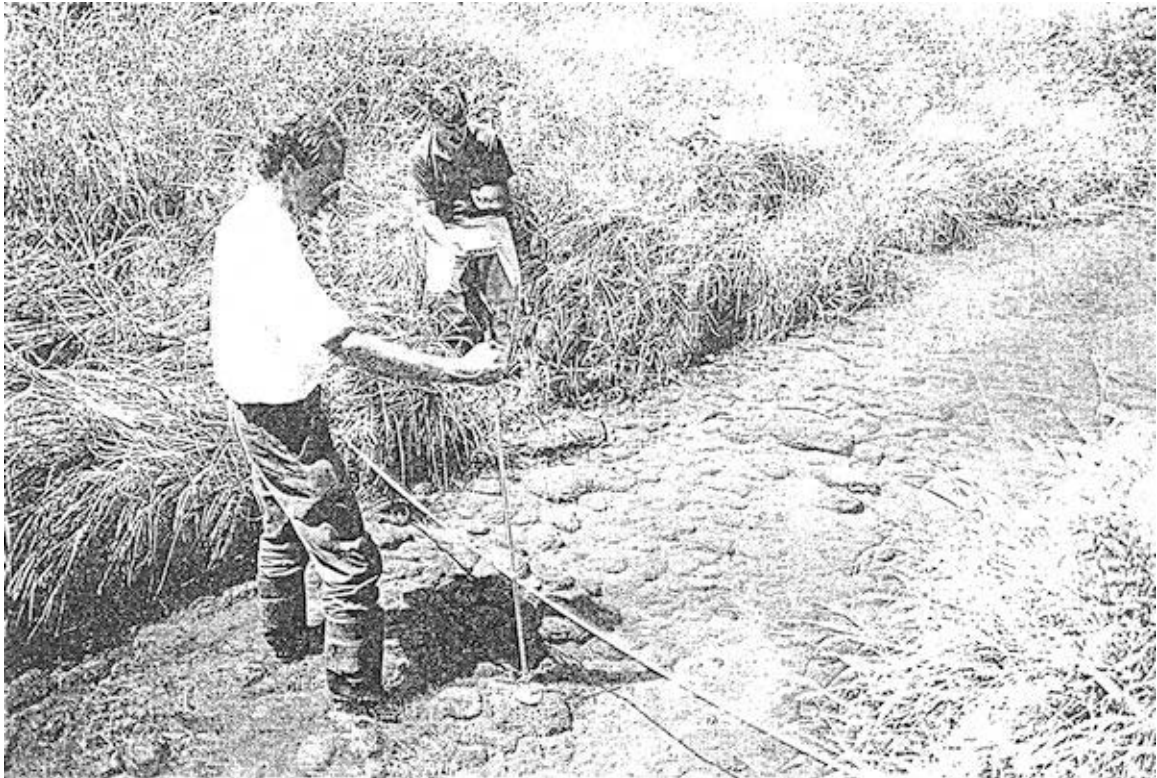
**Fig 7:** A current meter is used to calculate stream velocity in low flow conditions.

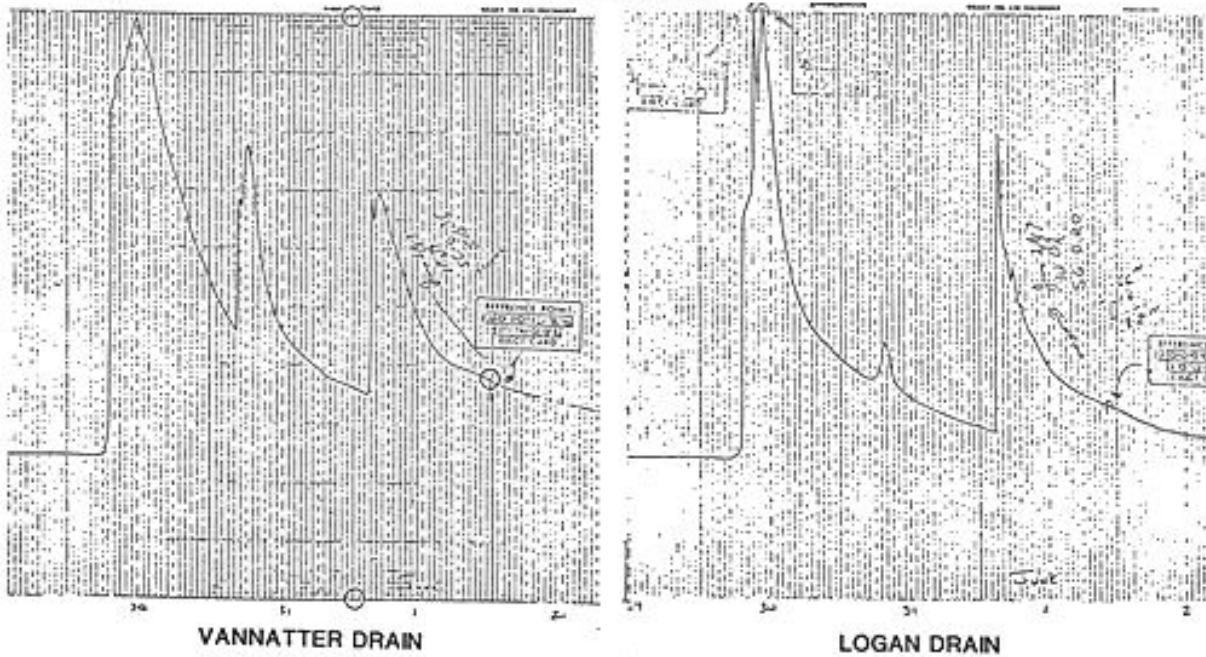
The water levels at the outlets were monitored by A-71 Stevens recorders. The charts from these recorders are digitized so hourly flows can be computed at each outlet. Stage discharge curves are maintained at each of the seven stations, the flows are gauged with a Pymy-Price current meter. A Bats unit has been installed at station 6. The unit has helped assure runoff events are not missed. Staff can keep accurate account of the runoff event from the office. The unit has also helped determine the different characteristics of the two drains. The Logan drain responds more quickly to an event than the Vannatter (Fig. 8). The drains are sampled accordingly.

**Figure 8:** The Logan Drain responds more quickly to runoff events.

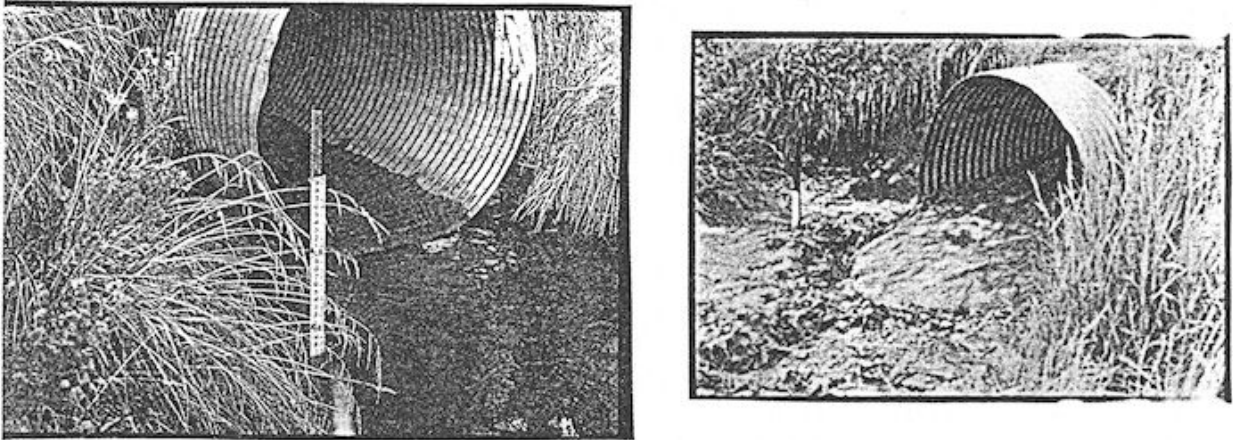
**Fig. 9:** Low flow and high flow conditions at Station 2.

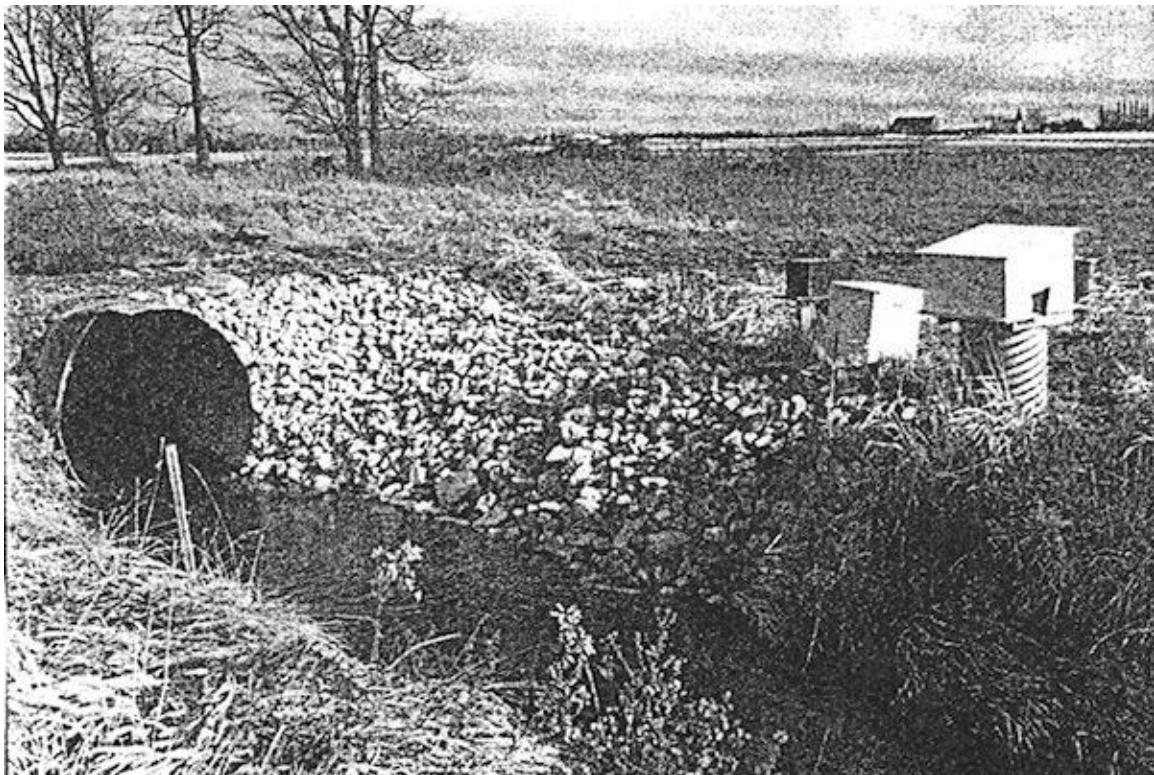
Streambank revetment was completed at the outlet to the demonstration basin (fig. 10). Ten meters of rip rap and filter cloth material were required to stabilize the bank and protect the monitoring equipment. Repairs were also made to the access laneways to the two outlet stations. The repairs were necessary to assure samples were collected during runoff events.

**Fig 10:** Repair to the stream bank at Station 1

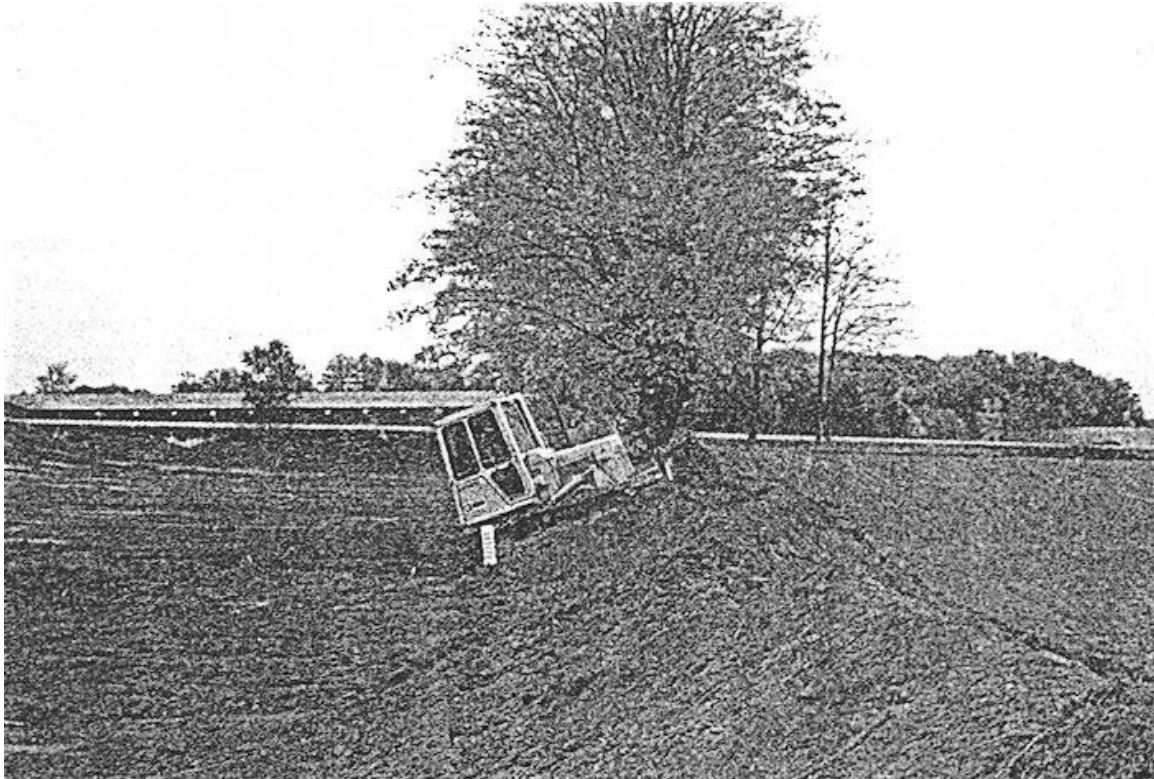
Two structural projects were completed during the fall of 1987. A water and sediment control basin (fig. 11), and grassed waterway/diversion. Both were completed on J. McMurray property. Two projects are still planned in the demonstration subbasin. One could be completed during the spring of 1988. The other conflicts with the Ontario Drainage Act. The landowner must work in accordance with the Act if the work is to be completed.

**Fig. 11:** WASCOB Construction on the McMurray Property.

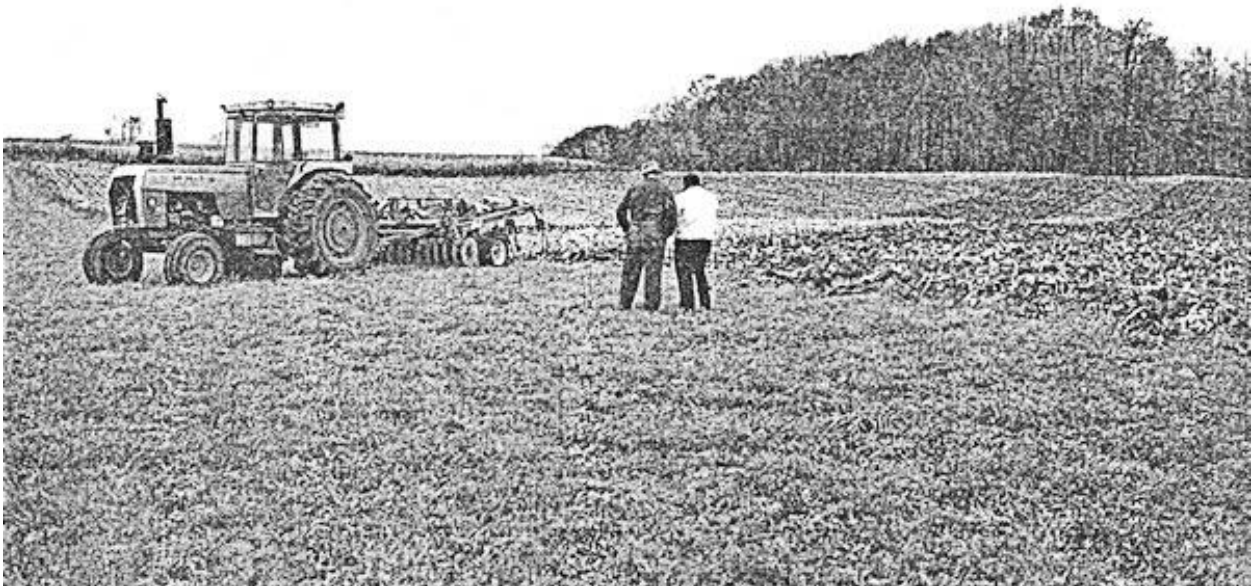
A Glencoe 7-shank Soil Saver was used in the subbasin. The machine was supplied by the local JSWCP as part of their commitment to the study. A John Deere mulch finisher has been acquired from the JSWCP. This machine is designed for single pass seed bed preparation on mulch tilled land.

**Fig. 12:** Corn ground should be mulch tilled on a 30° angle to the rows.
