**UPPER THAMES RIVER LIVESTOCK
MANURE AND WASTE MANAGEMENT PROGRAM
1985 - 1986**

Prepared by: D. Hayman
C. Merkley

For: Ministry of the Environment
Southwest Region

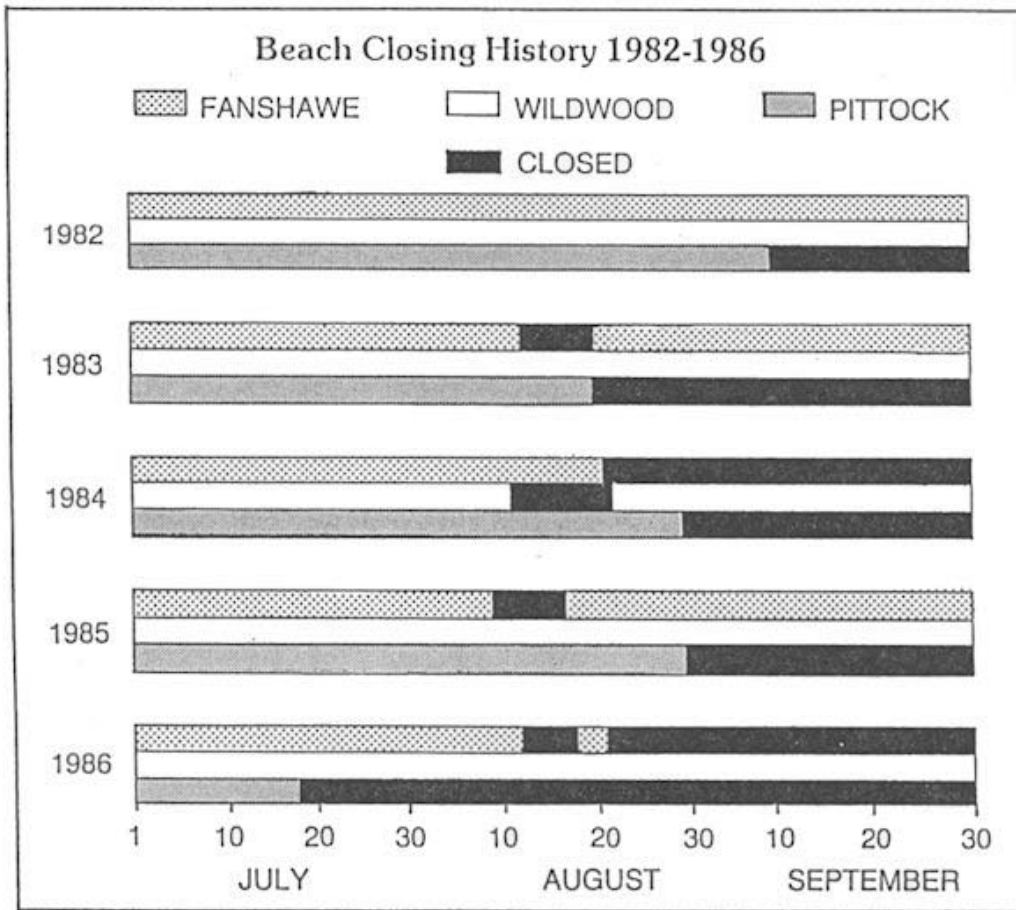
Figure 2: Beach Closing Summary From 1982 - 1986
For Fanshawe, Wildwood and Pittock Reservoirs

Figure 2 outlines the beach closing history of Fanshawe, Wildwood and Pittock Reservoirs between 1982 and 1986.

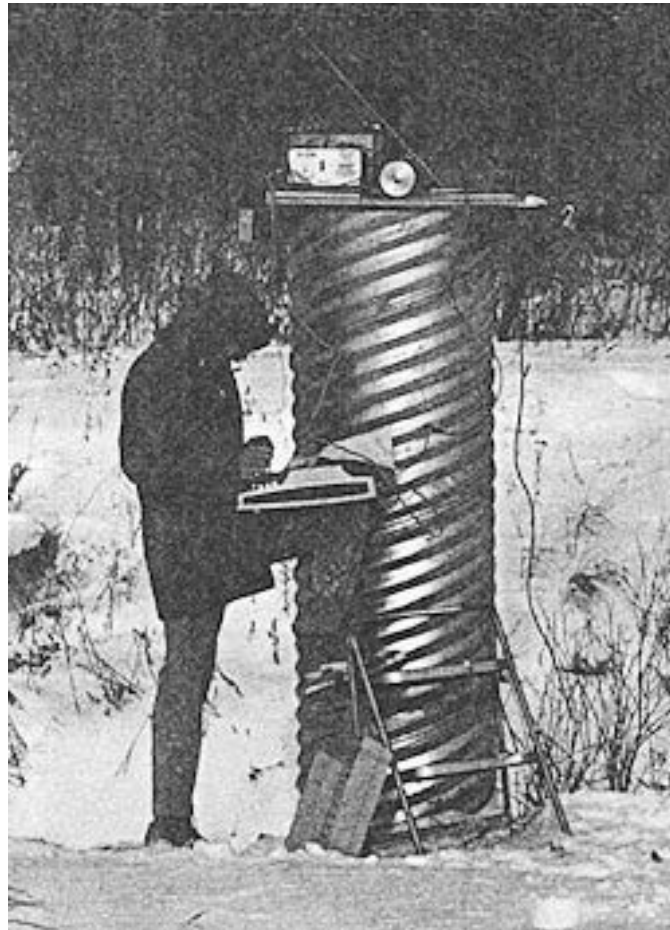
Staff regularly monitor the Kintore Creek watershed to estimate the amount of eroded soil reaching the stream.

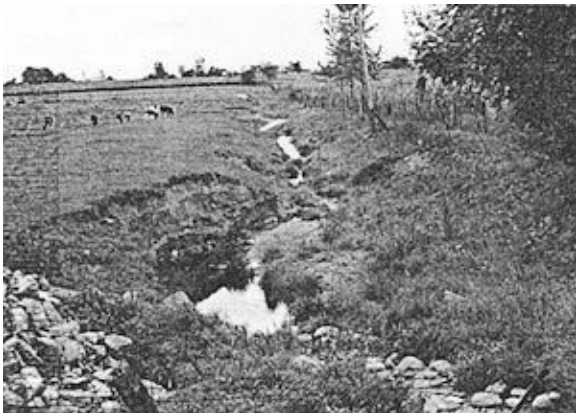
Under dry weather conditions, the Kintore Creek maintains a base flow.

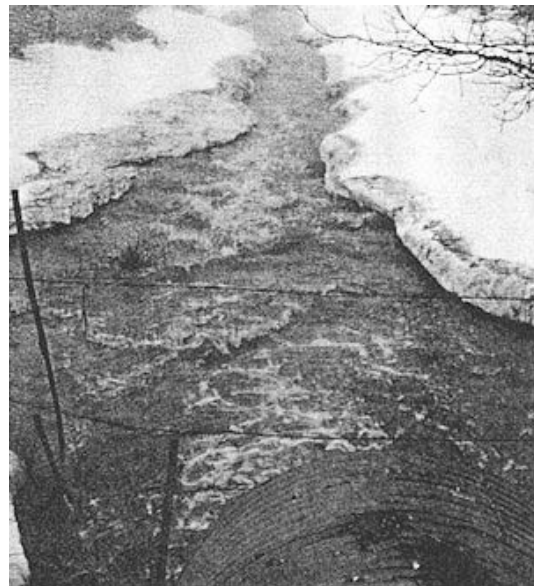
After runoff events, flows can increase 20 to 40 times base flows, carrying with it large amounts of eroded soil.
