**DOCUMENTATION OF THE NUISANCE ALGA,  
*Cladophora*  
IN THE SYDENHAM RIVER  
GREY COUNTY**

**June 1992**

by: J. Westwood and M. Johns  
Ministry of the Environment Technical  
Assessment Section Southwestern Region

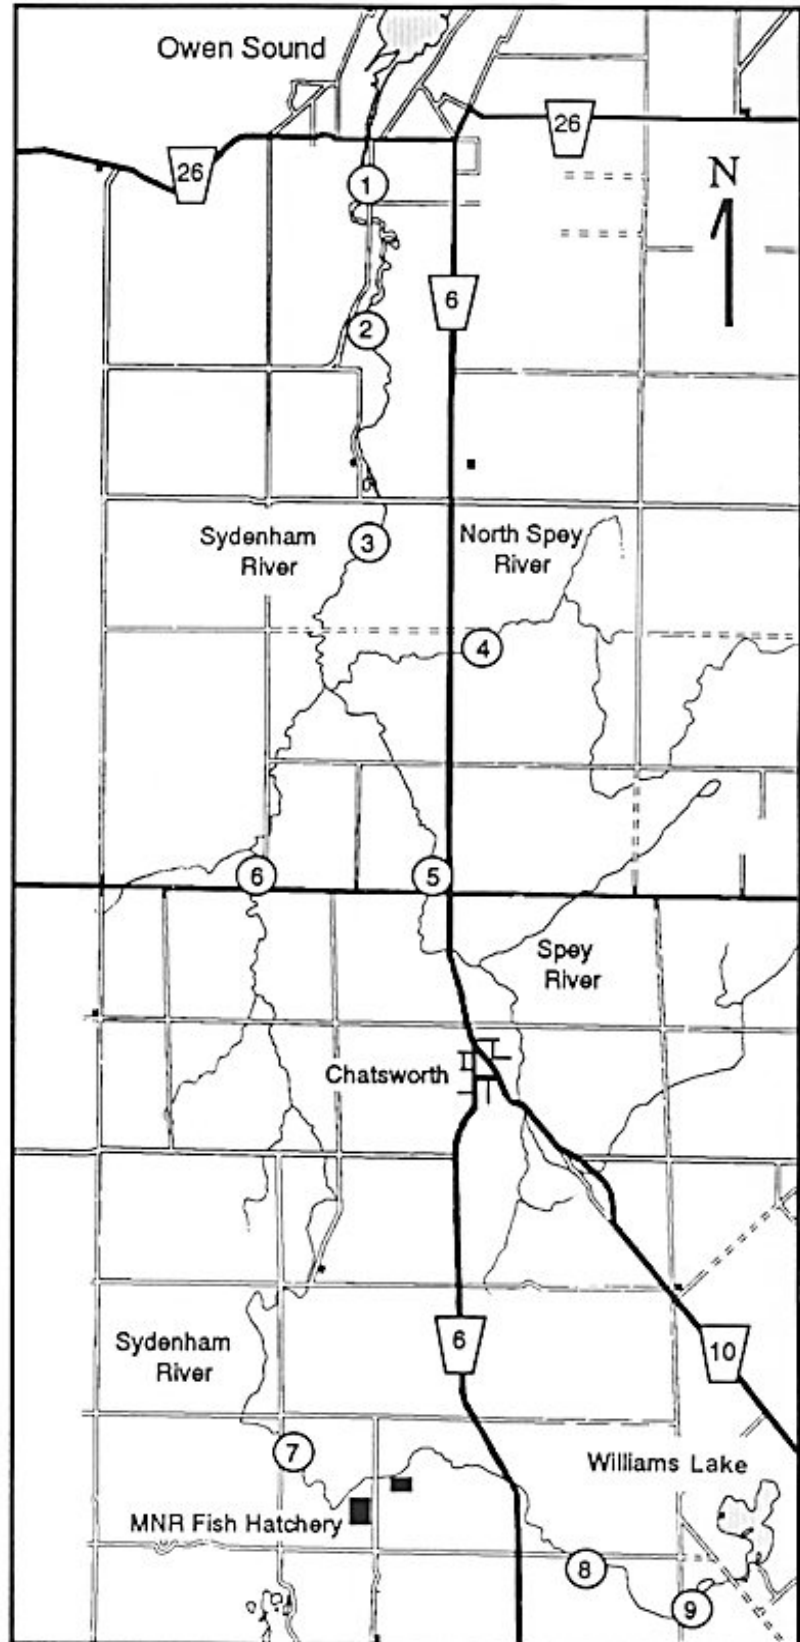
**Figure 1:**

The study area and sampling locations are shown on Figure 1; a map of the Sydenham River. Table 1 documents the *Cladophora* growths observed and the potential of the habitat conditions to support the growth of *Cladophora* in the upper river.

Location of transects and sampling sites on the Sydenham River, June, 1992.

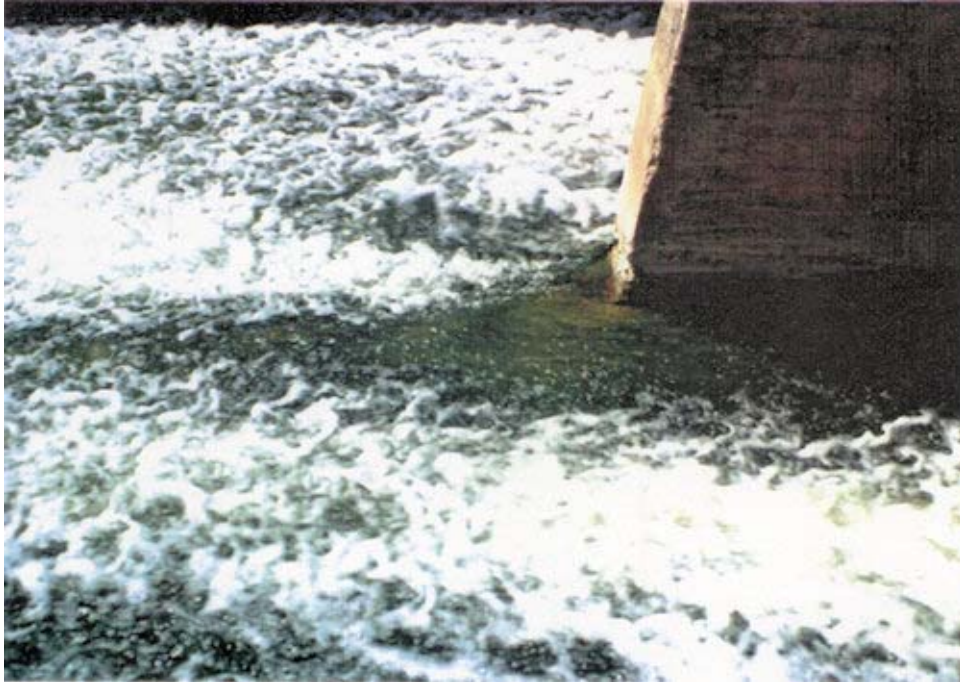
Visual observations June 1 - 3, 1992 documented nuisance growths of *Cladophora* in the Sydenham River upstream from Inglis Falls to downstream of the Mill Dam in Owen Sound. This alga covered the cement spillway of the Mill Dam (Plate 1) and the cobble rock substrate downstream, for a distance of approximately 140 metres at which point substrate conditions become the limiting factor (sand, silt).

**Plate 1:** *Cladophora* growing on the cement spillway of the Mill Dam.

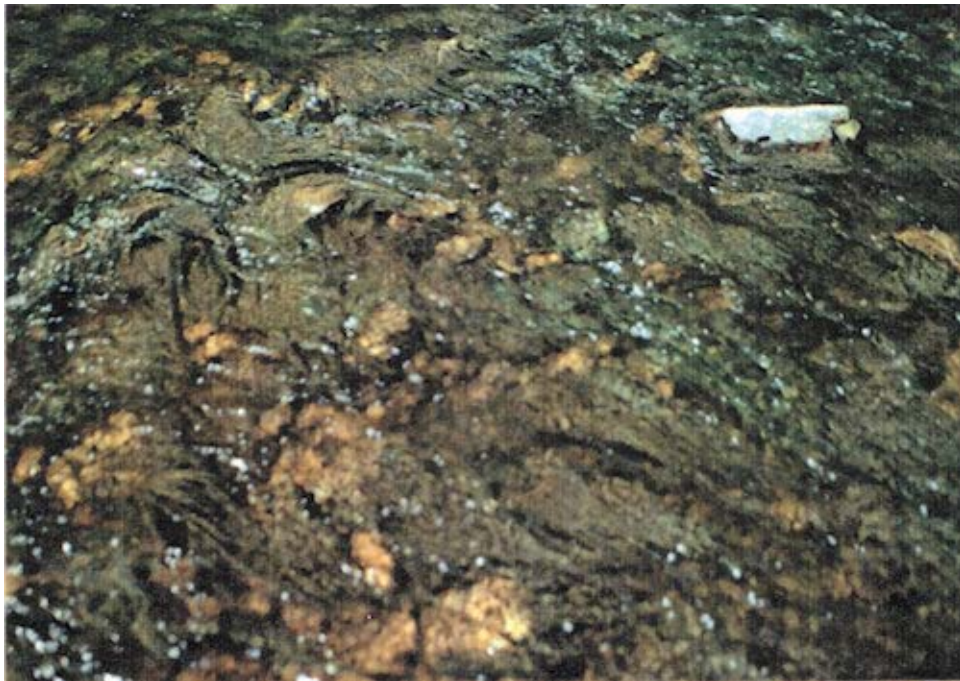
**Plate 2:** Heavily silted and dying *Cladophora* in slow flow area downstream of Mill Dam.

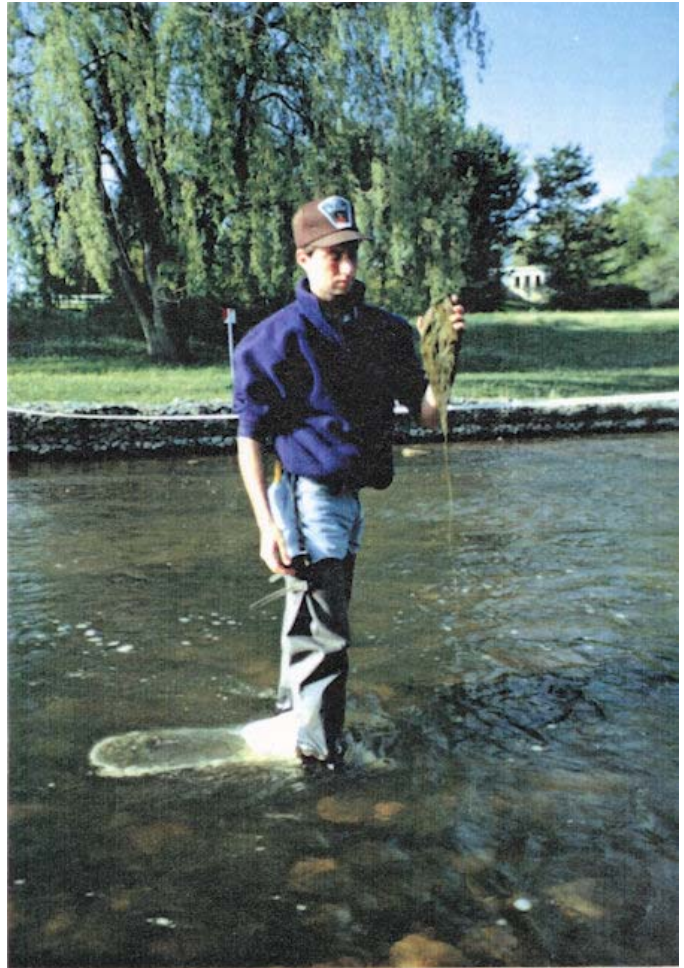
**Plate 3:** (right)  
Sampling *Cladophora* at  
transect 1, downstream from  
Mill Dam.

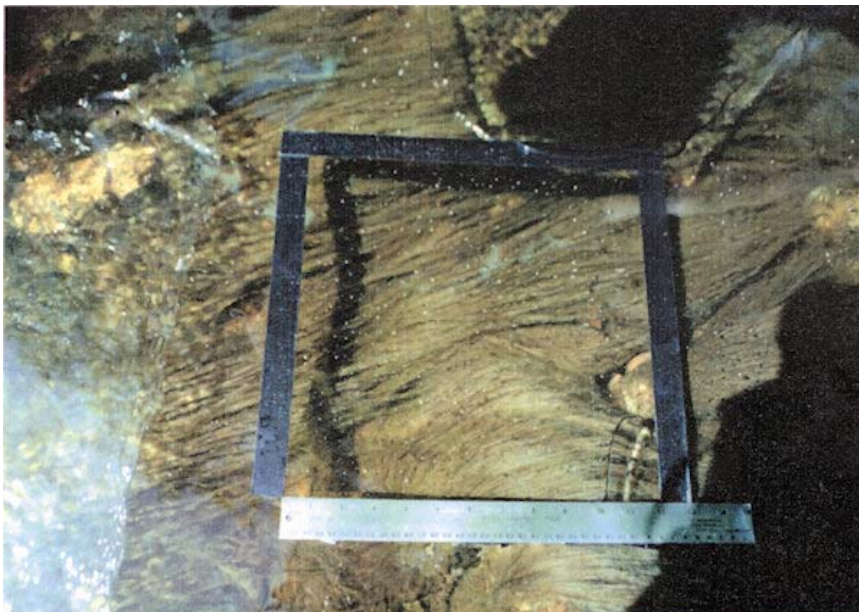
**Plate 4:** (below)  
*Cladophora* covered substrate  
in a fast flow area,  
downstream from the Mill  
Dam, as viewed through a  
0.09 m<sup>2</sup> plexi-glass sheet.

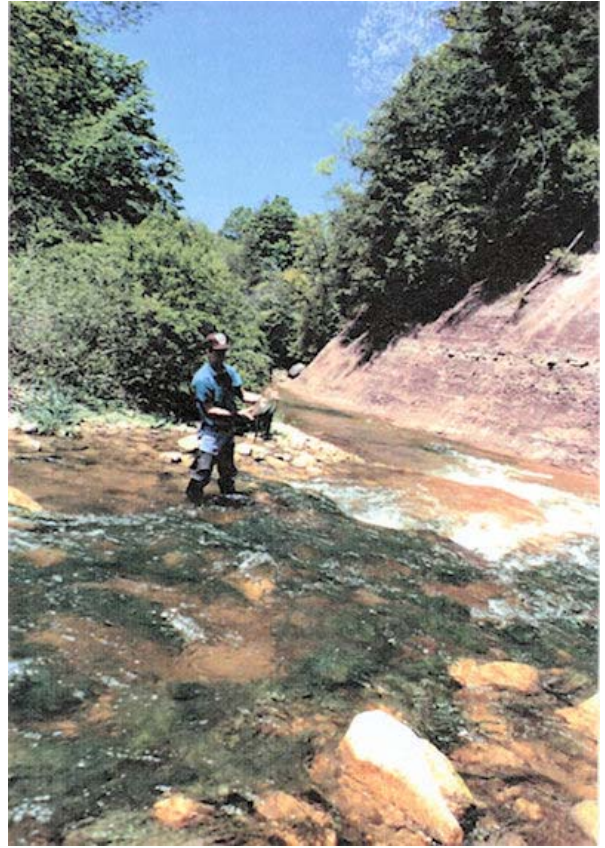
**Plate 5:** (right)

*Cladophora* growth in the fast flowing section of river between Harrison Park and Inglis Falls.

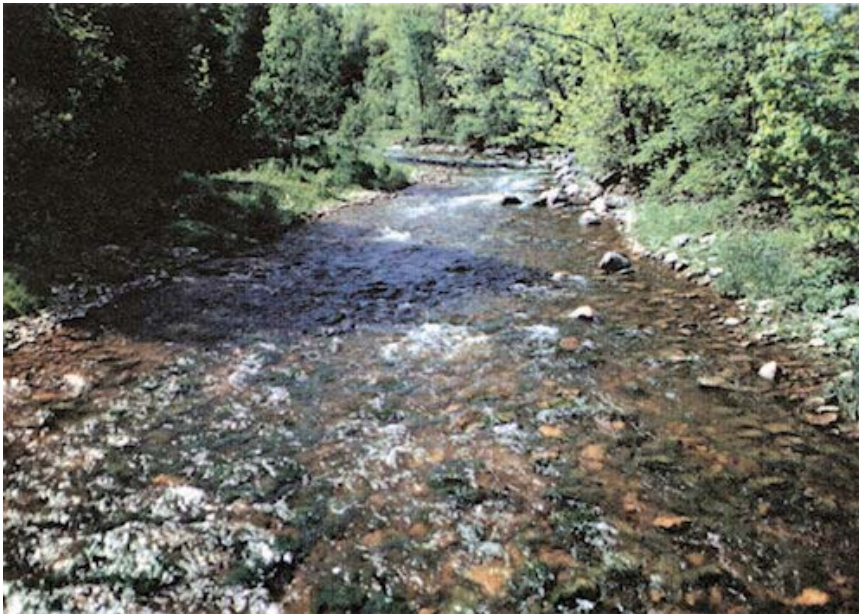
**Plate 6:** (below)

*Cladophora* growth upstream from transect 2 in Harrison Park.

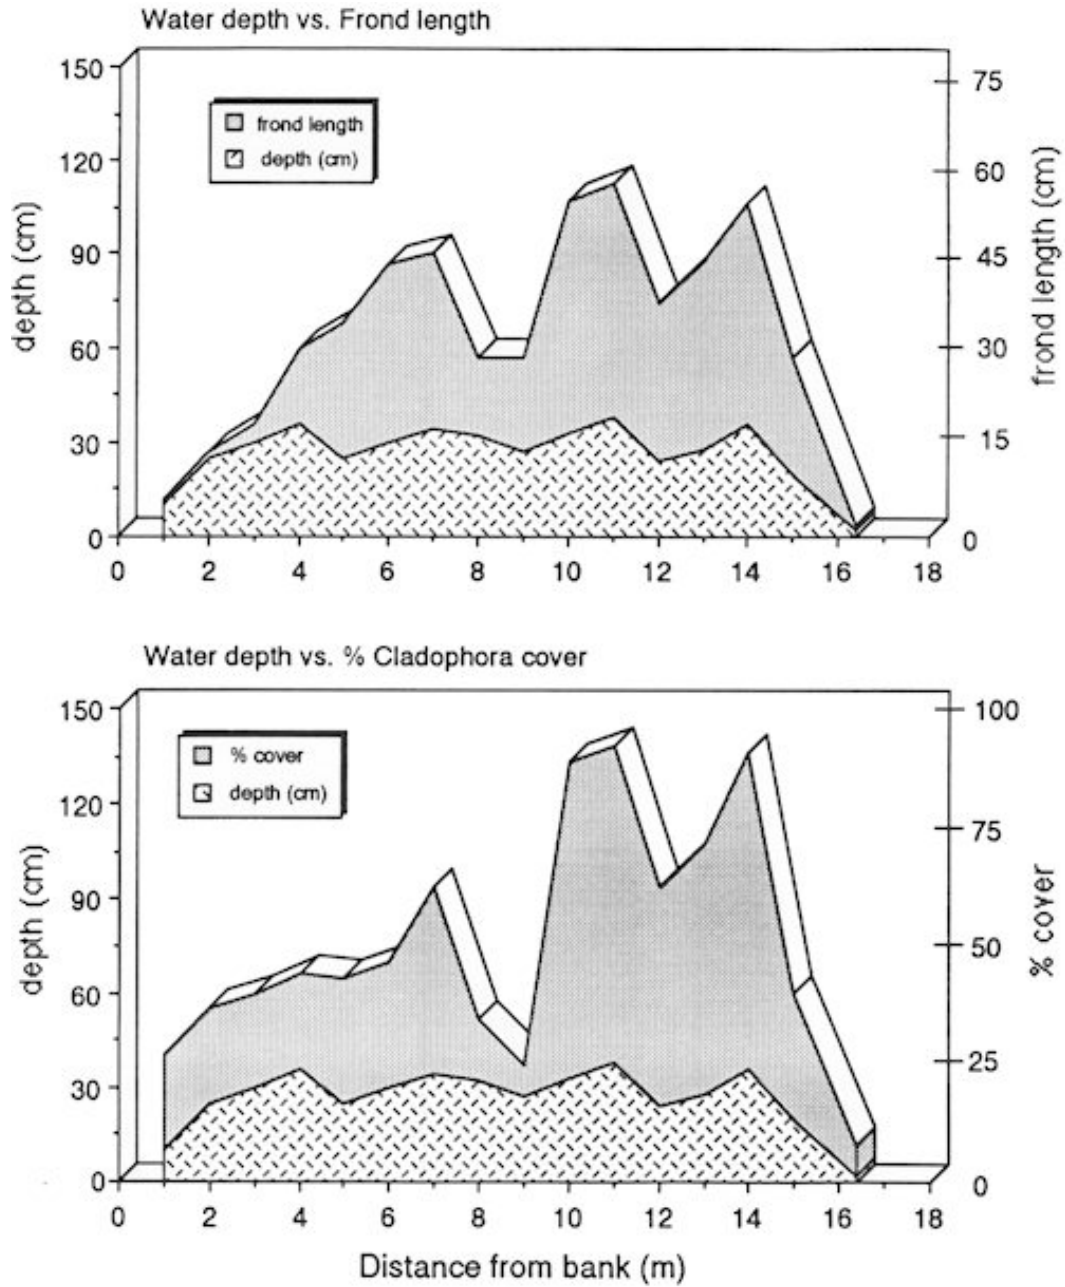
The cross-sectional profile of the river 90 metres downstream from the Mill Dam is graphically depicted in Figure 2. The *Cladophora* growths illustrated are representative of the entire growth area downstream from the dam. The shallower, slow flow sections of the river contained heavily silted, rotting deposits of *Cladophora* (Plate 2). The fast flow sections contained lush green growths with maximum frond lengths reaching 75 cm (Plate 3 and 4). Table 2 provides information on the physical data collected: river width, depth, percent *Cladophora* cover, maximum frond lengths, and wet, air dried and oven dried weights of the *Cladophora* samples. This data will be useful for future comparisons.

**Figure 2:** Observations along site 1 transect , located downstream of Mill Dam in Owen Sound.

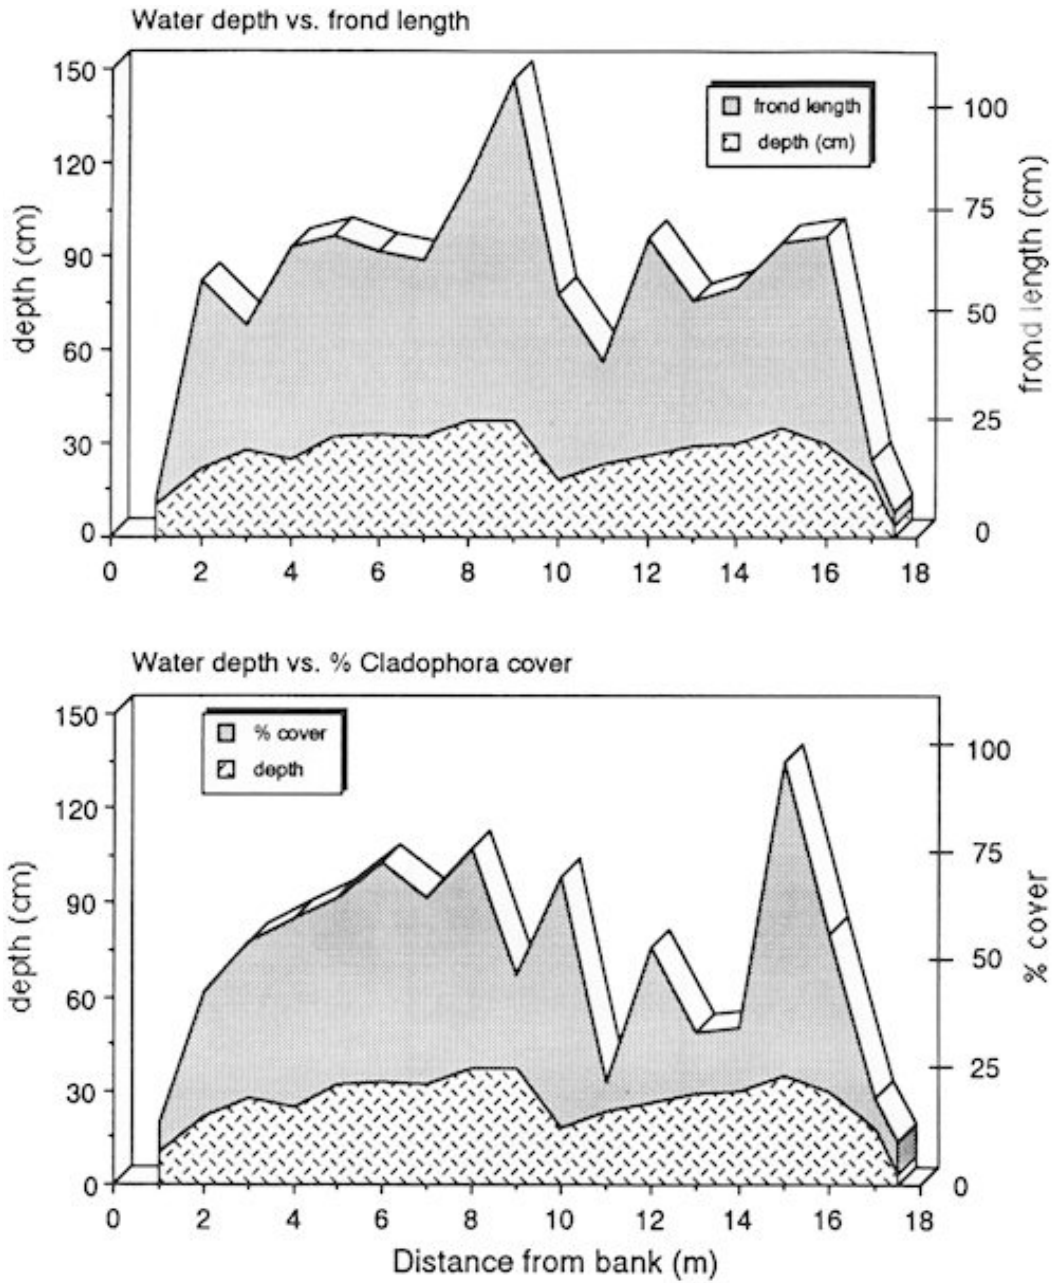
The second cross-sectional profile of the river was established in Harrison Park upstream from the Mill Pond. The stream flows rapidly over rock and cobble substrate in this section. The river valley is heavily forested and the stream shaded. Despite the shading provided by the hardwood forest cover, *Cladophora* was thriving (Plates 5 and 6). Figure 3 depicts the growth present on June 2, 1992. This sample site produced

**Figure 3:** Observations along site 2 transect, located in Harrison Park.

the maximum frond length observed; 110 cm and the heaviest dry weight per 0.09 m<sup>2</sup> sampled (Table 2B). Plates 7 and 8 document the luxuriant *Cladophora* growths on and at the base of Inglis Falls.

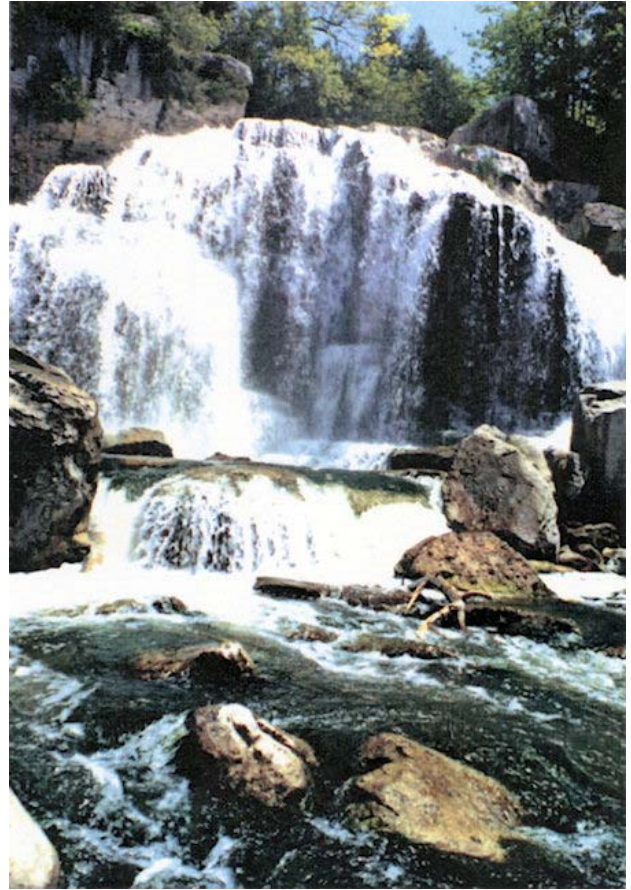
**Plate 7:** (right)  
Luxuriant growths of *Cladophora* on  
and at the base of Inglis Falls.

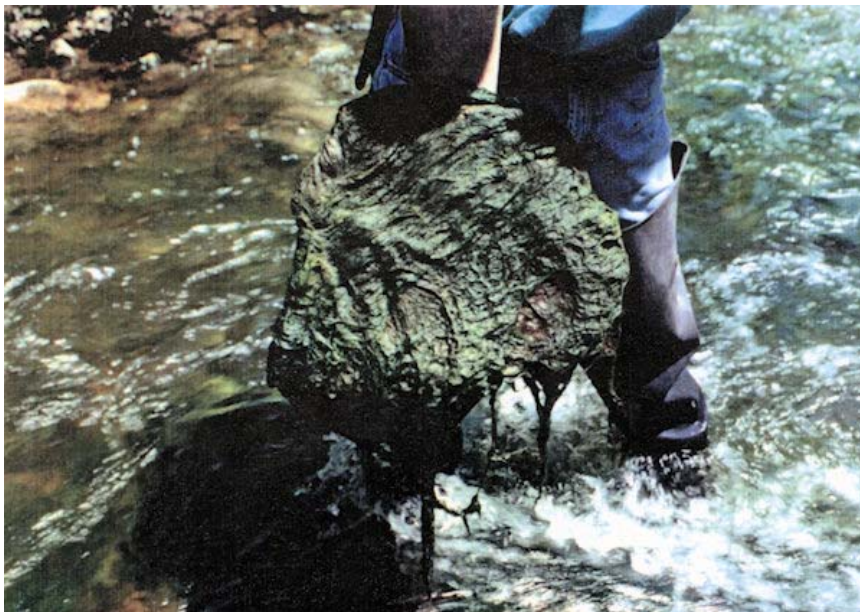
**Plate 8:** (below)  
*Cladophora* covered rock at the base  
of Inglis Falls.

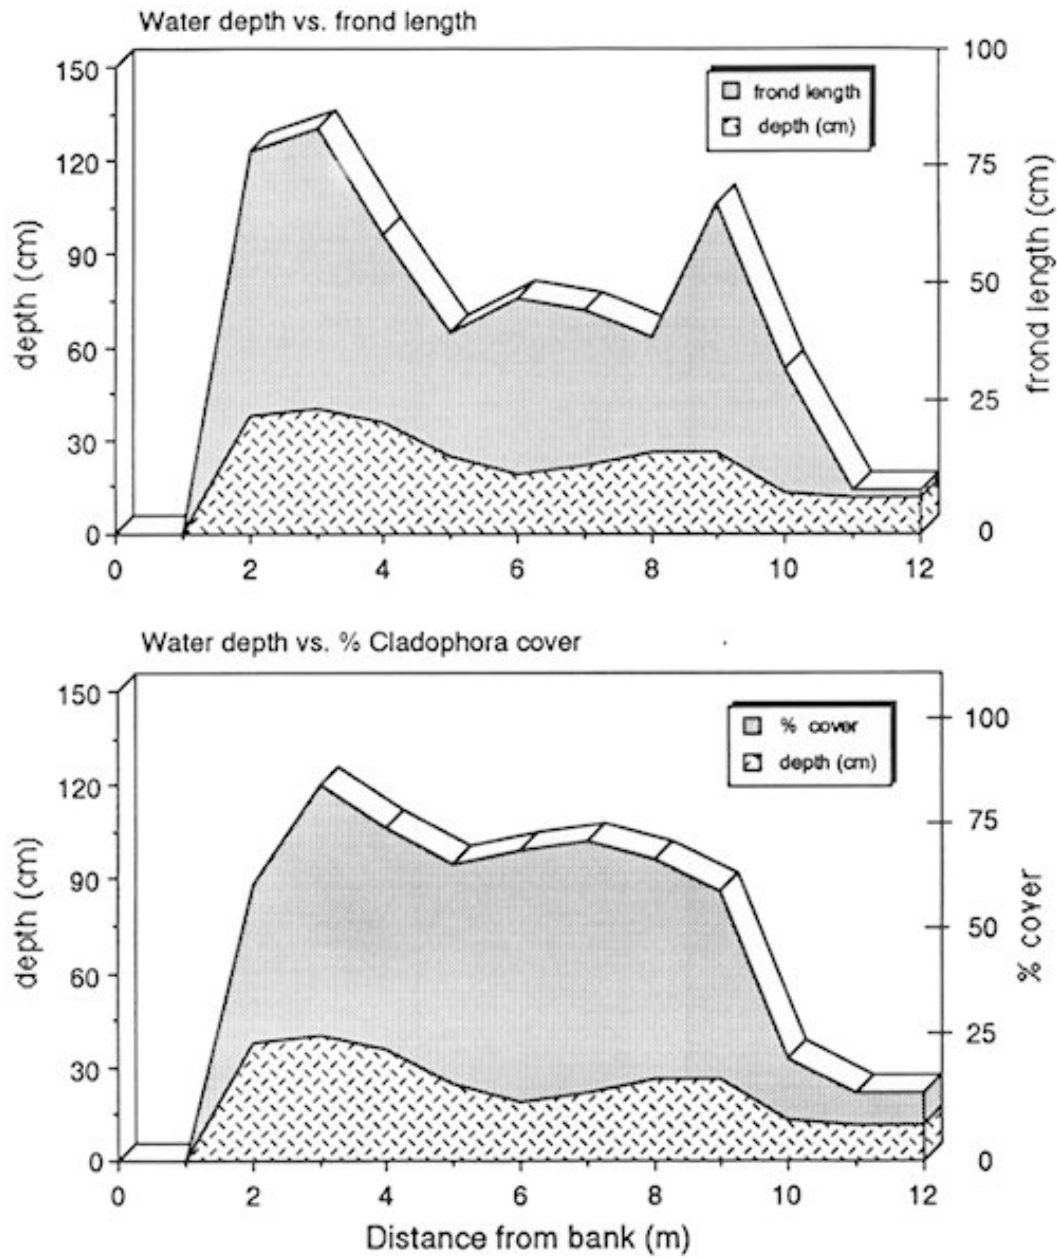
Cross-sectional profile 3, was established 20 metres downstream from the old waterworks dam south of Grey County Road 18, upstream from Inglis Falls (Figure 4). *Cladophora* growths appeared at their peak level of production at this site. Large masses easily broke free when disturbed and moved downstream with the current. *Cladophora* covered the cement spillway and was observed on the cement dam abutments. Due to the poor physical condition of the alga at this site, it was difficult to obtain a representative wet weight (Table 2C). The 0.09 m<sup>2</sup> samples could not be properly dried with a paper towel due to their fragile condition. It is at this stage in its growing cycle that *Cladophora* can rapidly slough off, disappearing in a matter of hours or days.

**Figure 4:** Observations along site 3 transect, located above Inglis Falls.
