THE UPPER EAST SYDENHAM RIVER WATERSHED WATER QUALITY STUDY, 1988

St. Clair Region Conservation Authority
and the
Ministry of the Environment

THE UPPER EAST SYDENHAM RIVER WATERSHED WATER QUALITY STUDY

September 1988

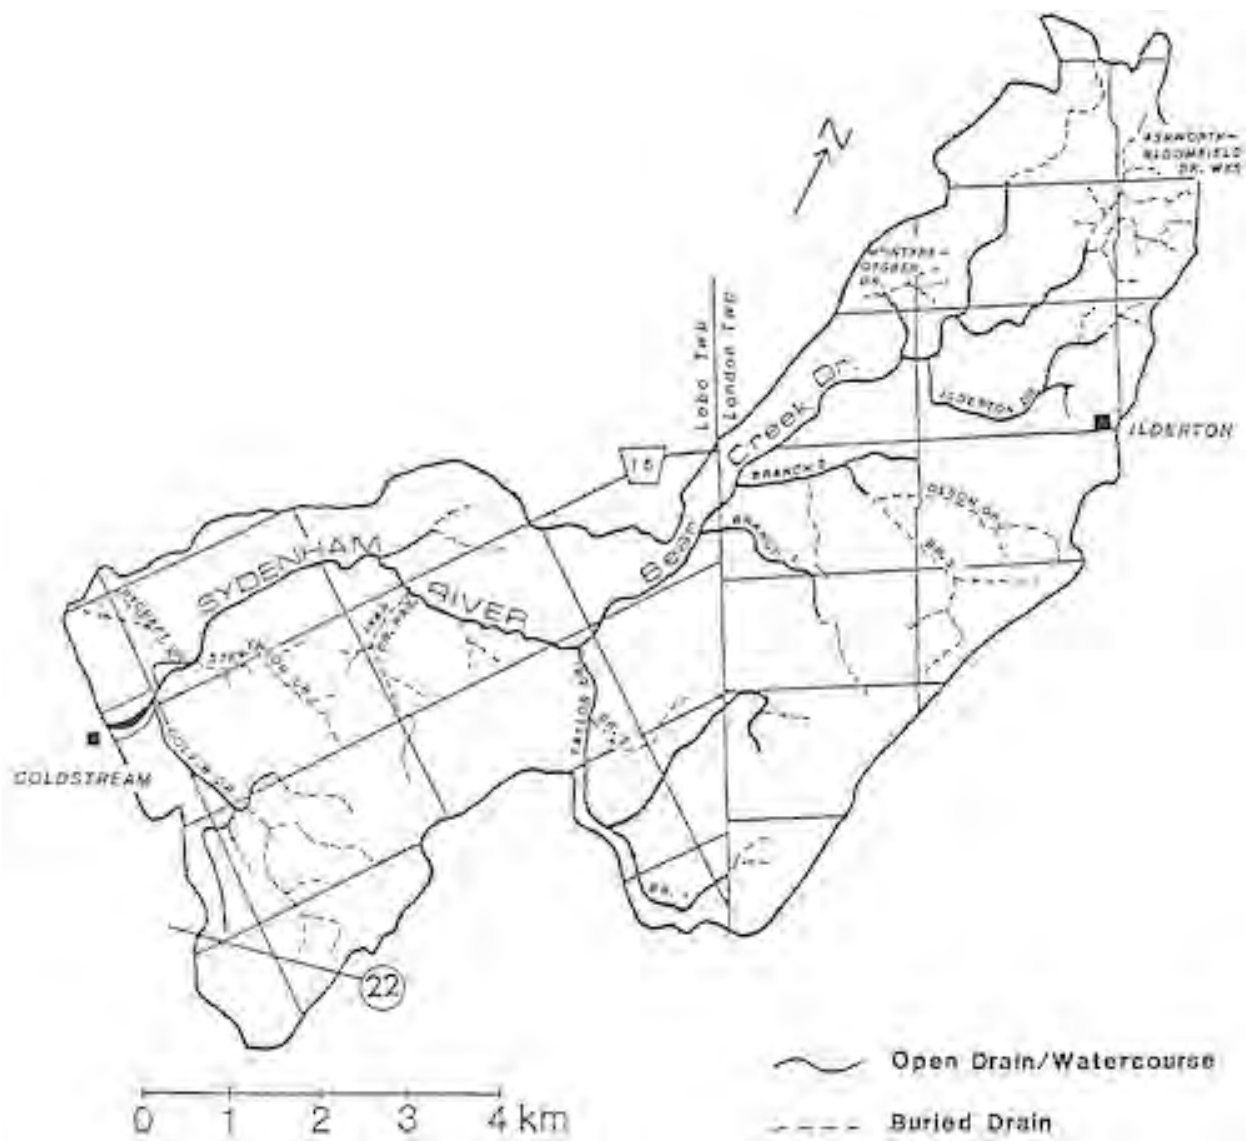
FIGURE 7. The Drainage Network of the upper East Sydenham River watershed

The upper East Sydenham River passes through a relatively flat clay plain with resulting low stream gradients. The elevation difference is only 30 meters from source to mouth. The headwaters of the upper East Sydenham River originate in the western portion of London Township just north of the Town of Ilderton. The river flows south-southwest towards Lobo Township and then south and west towards the Town of Coldstream where it empties into the Coldstream Reservoir (Figure 7).

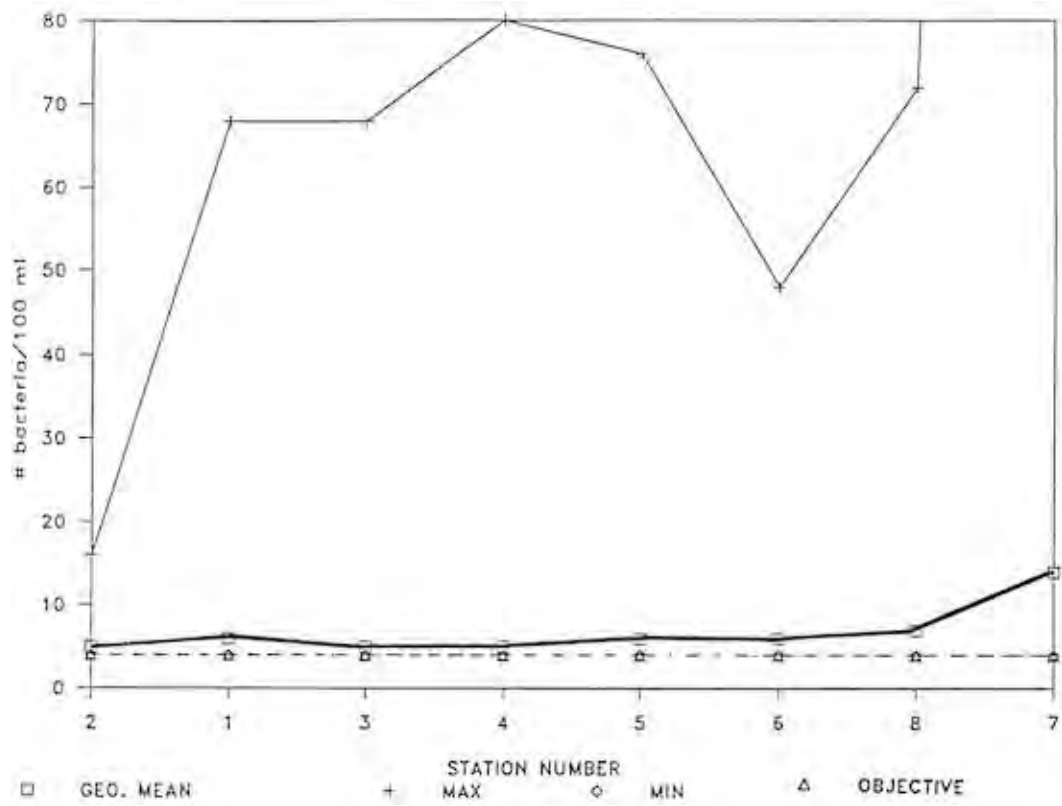
Figure 12. *Pseudomonas Aeruginosa* Levels

Figure 12 illustrates the low degree of variability between the stations in terms of their geometric means, except for Station 7. The Max curve demonstrates the very high levels which do sporadically occur. The majority of these elevated values occurred on wet dates, specifically Oct. 26 and Nov. 9, 1987 and Jan. 18 and Feb. 1, 1988. The latter two were mid-winter thaws causing elevated pollution levels in all categories. Human wastes are somehow reaching the drains during these periods perhaps from septic system weeping bed overflow which is exacerbated by frozen ground. Station 7 is the only station which recorded consistently excessive *P. aeruginosa* levels.

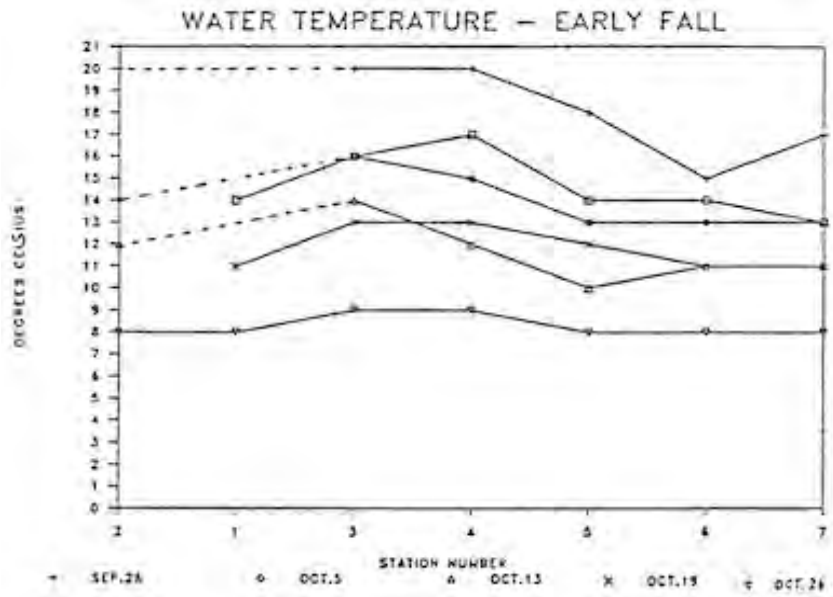
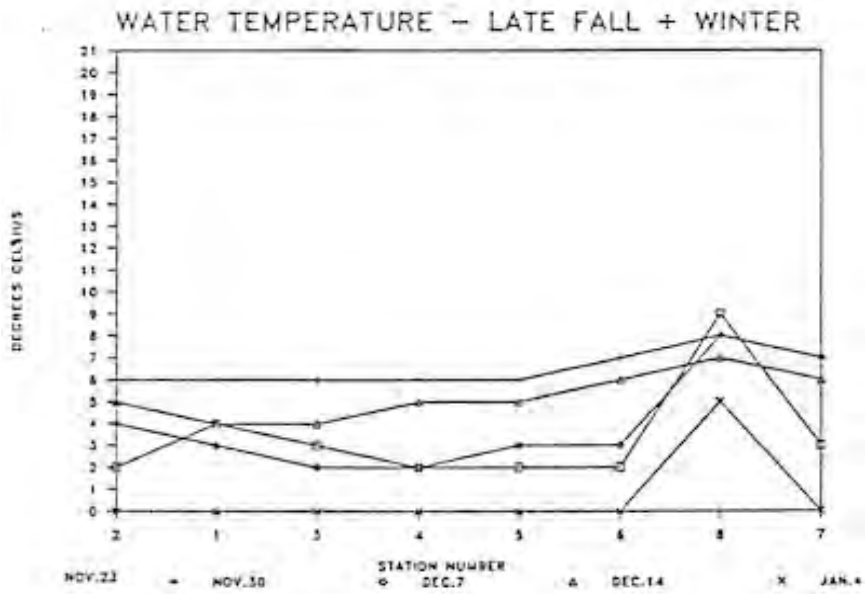
Figure 14.
Water Temperature
