West Credit Subwatershed Study

Characterization Report

January 1998

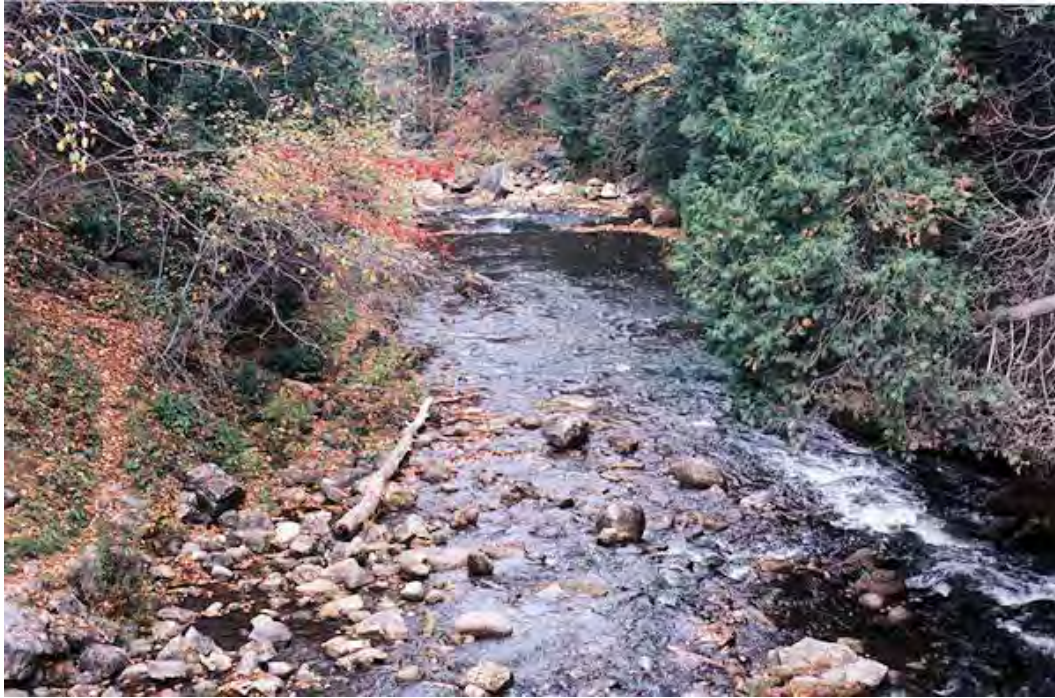
Figure 3.3.2: B - Type Channel, looking downstream from the Belfountain Dam*

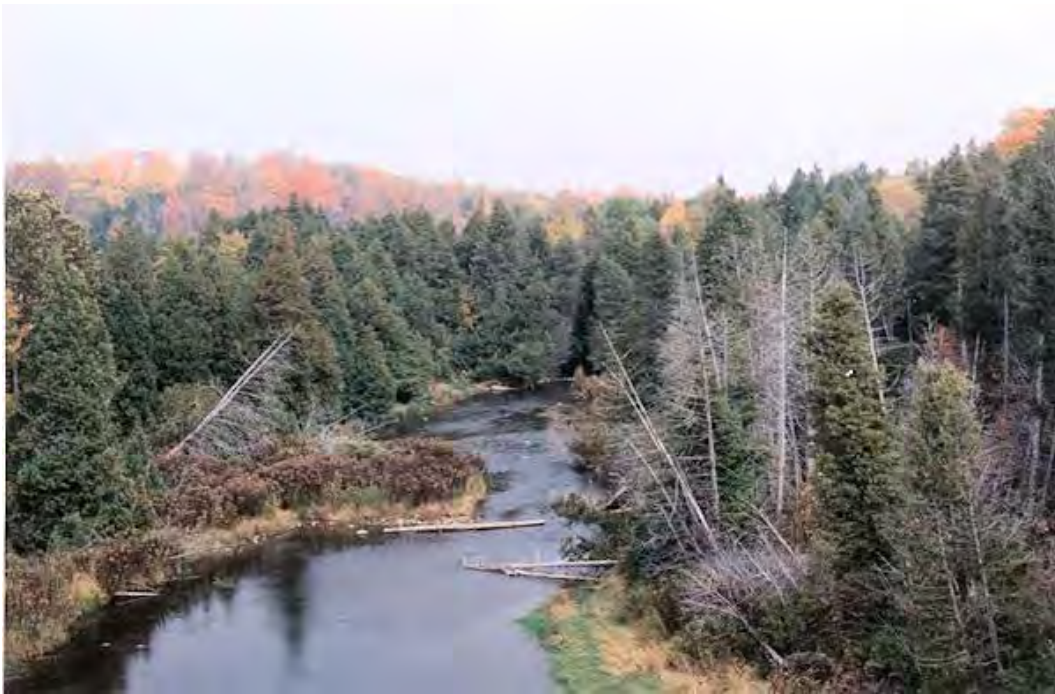
Figure 3.3.3: C4 Channel, looking downstream from Shaws Creek Road

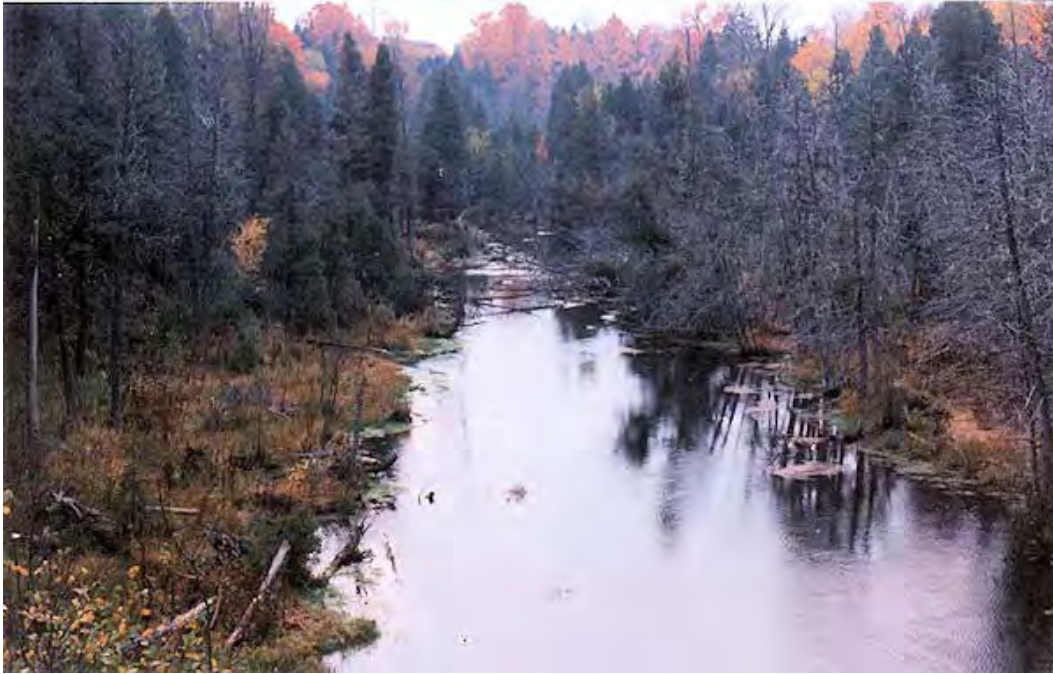
Figure 3.3.4: C5 Channel, looking upstream from Shaws Creek Road

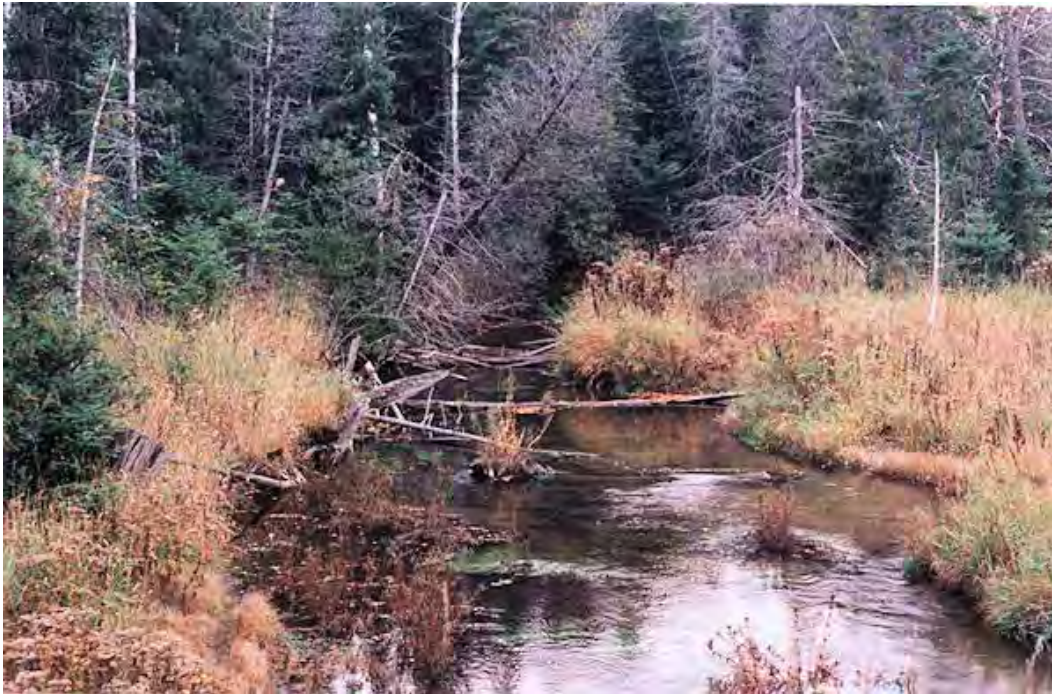
Figure 3.3.5: C6 Channel, looking upstream from Highway 25

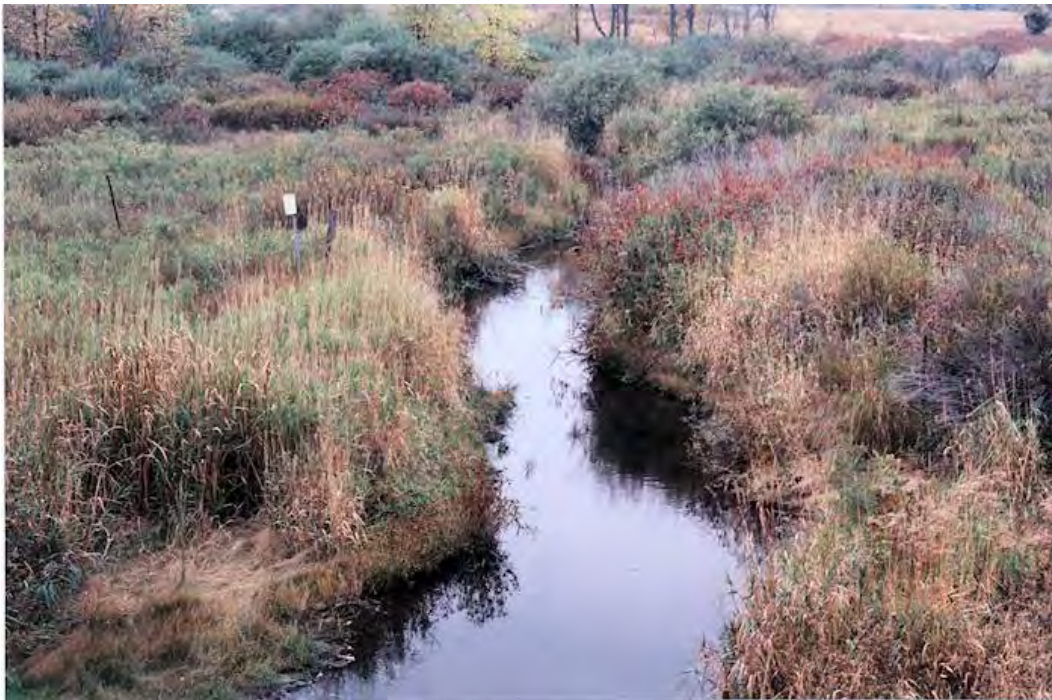
Figure 3.3.6: E Channel, looking upstream from Highway 24.

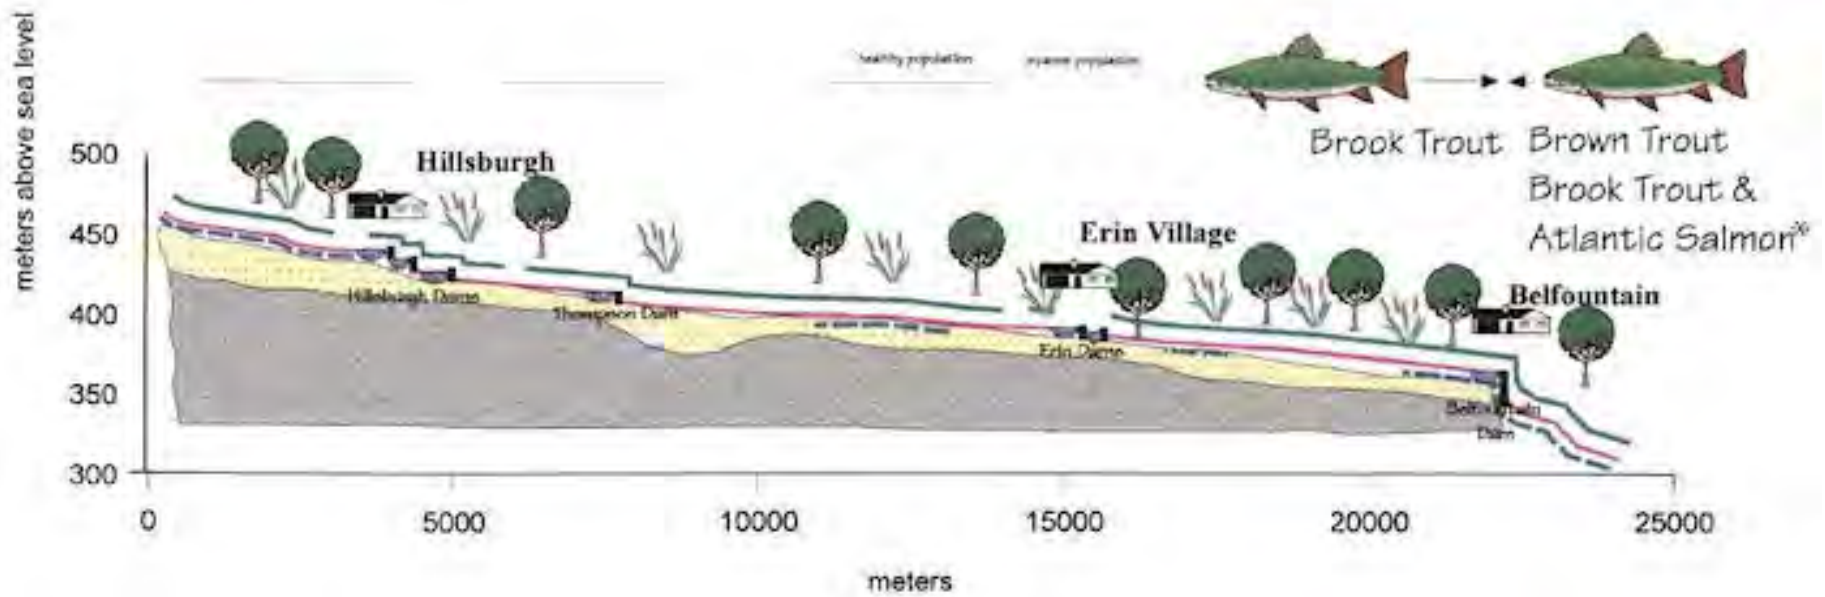
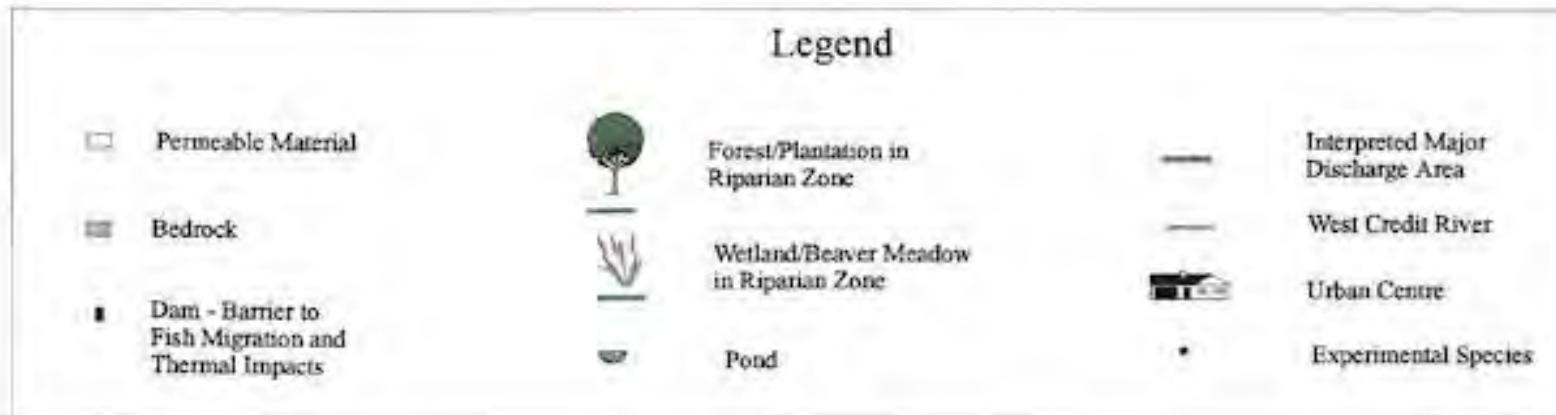
Figure 4.1.4: Cross Section of the Main Branch of the West Credit River - Riverine Characteristics
